Postwar Crankcases for Single Cylinder Engines

Colin Farrington reveals all

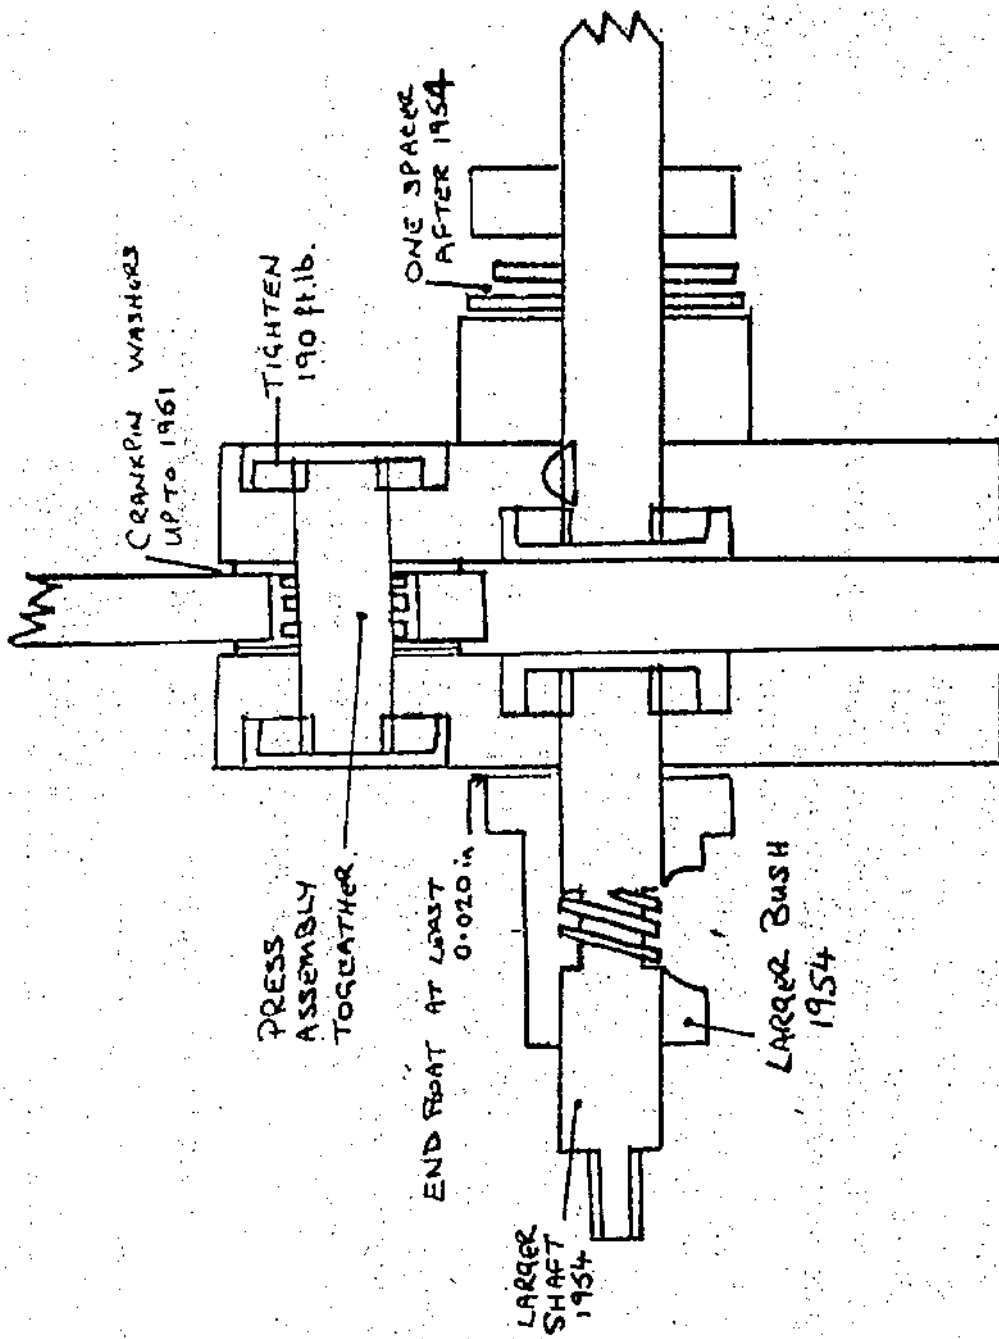
Section through single cylinder flywheel assembly, showing changes up to 1955
