# AJS gearbox rebuild

Virgin restorer Neil Webster looks at the internals of his little AJ's gearbox and immediately calls in expert Bill Redford to undertake the strip and rebuild. Only the engine to do now...the bike will be on the road soon, promises Neil

## AJS 250 restoration: part nine

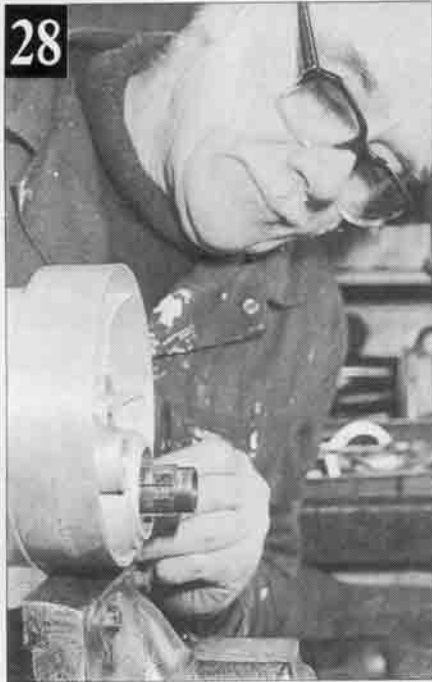
28

● With the shell then mounted in the vice the bearing surface of top gear was oiled (pic 27) and the gear fitted into the bearing (pic 28). The cluster was then re-assembled (pic 29), put back into the case as a unit and the selector fork spindle screwed in and tightened with a spanner (pic 30). The result should be as in pic 31.

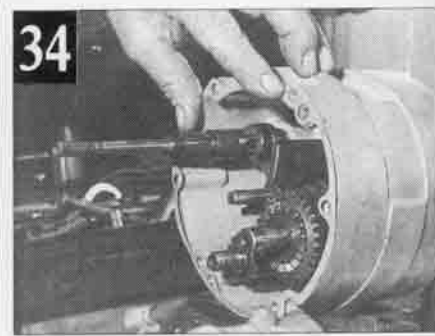
34

- The kickstart gear is then put into the cover and the spring prised into position (pic 33), making sure the spring isn't too tight, which could cause it to snap when used.
- The first gasket is then put in place (pic 34) after a good smearing with Silver Hermetite — which doesn't show up as much as red or blue versions. Another tip from Bill is to soak the gasket in water if it seems tight. Tightness is usually caused

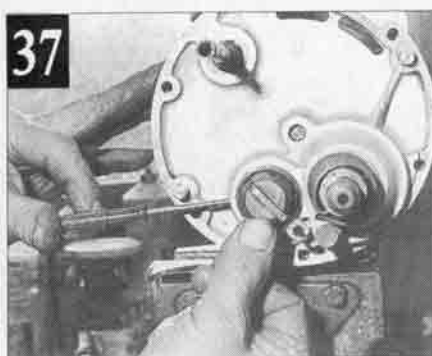
37

- After tightening the nut, check the mainshaft still rotates. The clutch operating mechanism is then fitted over the nut retaining the mainshaft, using a pointer through the hole in the housing shell to locate it in line with the cut-out in the mechanism itself (pic 37). You should also have a mark left during stripping to ensure things are correct, although as we used a new mechanism this wasn't relevant.

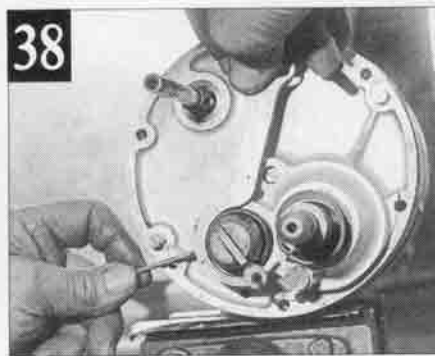
38

- With the mechanism located, a 'C' spanner tightens things up (pic 38). This is fiddly and can take time. Again, a punch and hammer can be used *with care* to do the job.

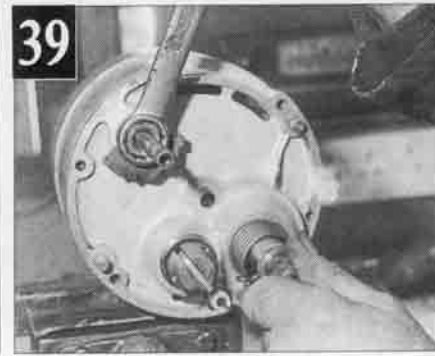
39

- The gear selector ratchet was replaced after checking its position against the selector fork housing, even though the item being refitted could be lined up against punch marks left during the stripdown (pic 39). The selector mechanism fits into the end cover, using a new spring if possible. This was not possible for us because the replacement pattern item proved to be very different from the original and impossible to fit (pic 40).
