Fettling AJS and MATCHLESS Two-fifties

SERVICE-
SHOP
LORE
No 13

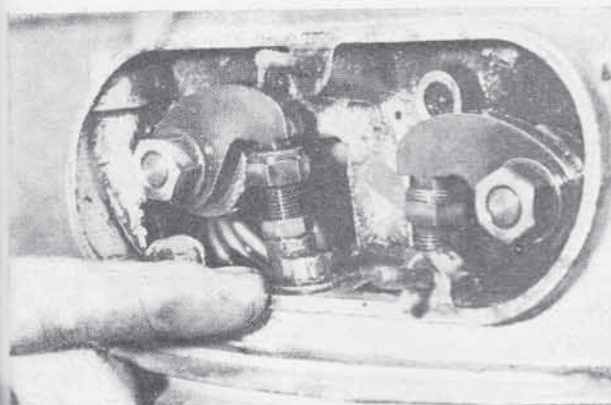
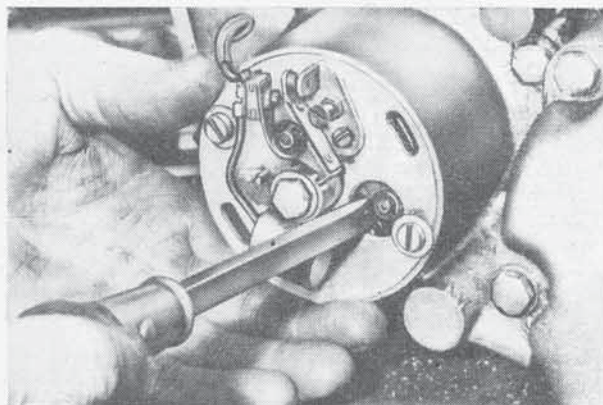
Left: Indicated is the rocker box retaining bolt which sometimes gets forgotten. The inlet valve is shown open. Both valves should be closed before attempting to remove the rocker box. Right: Before setting the timing, the bob-weights should be held in the advanced position.

WHEN removing the rocker box set the piston at about top dead centre with both valves closed; and remember that one retaining bolt cannot be reached until the inspection cover has been taken off.

The drill, therefore, is to lock the cam on full advance. To do this you remove the securing bolt and thread on to it a 3/16in-thick collar counterbored to clear the spindle end and bear against the cam.

Then, holding the bob-weights at full advance with the screwdriver, you have only to tighten the bolt lightly to lock the cam against the spindle shoulder behind it.

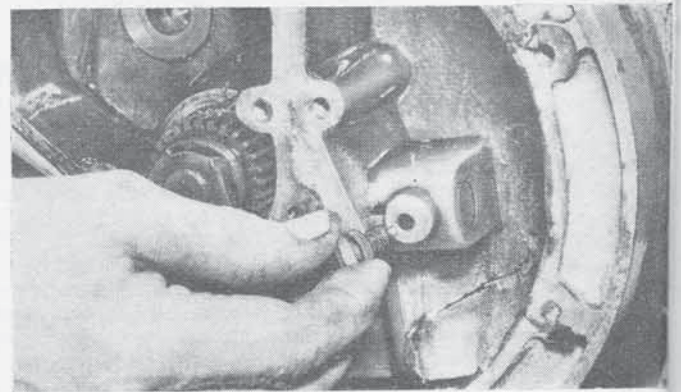
by a guide pin which engages in a profiled groove in the plunger. Wear on this guide pin, even to a very small degree, will affect the action of the plunger.

The result is that as soon as the engine is started oil pressure dislodges the cap, pressure is lost and the lubrication system fails.

Left: Wear on the end of the guide pin which engages in the profiled groove of the pump plunger will cause loss of efficiency. Right: When dismantling the oil pump there is no need to disturb this stud which merely retains a blanking cap

There is no need to remove this stud when the pump is being dismantled. Some owners do so, however, and occasionally fail to engage the pip with the groove.

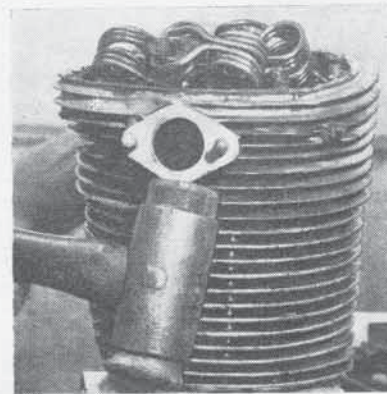
If the head is difficult to remove and it is necessary to use a hide mallet, the correct place is beneath the carburettor mounting flange

TO free the cylinder head sometimes calls for a little persuasion with a hide or plastic-face mallet. Best place to do the tapping is under the induction tract.

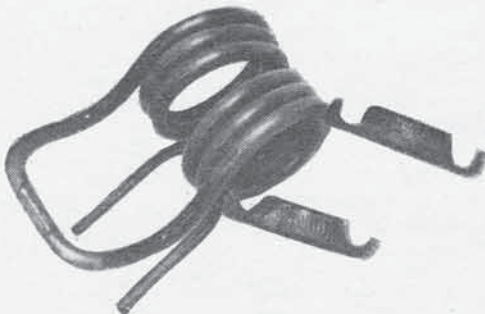
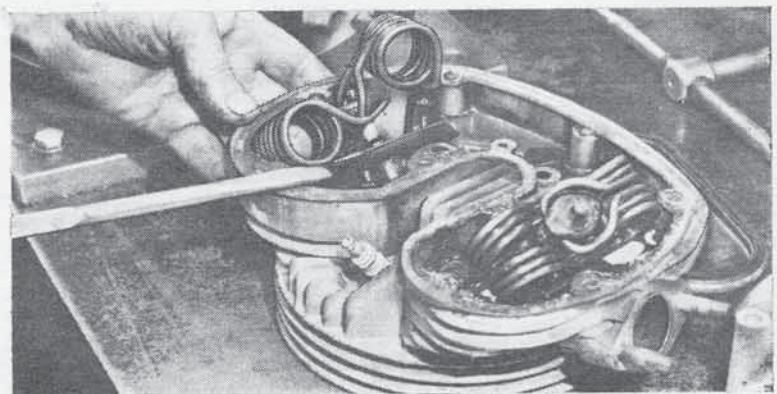
Above: Wear on the closed loops of the valve spring occurs where it engages with the collar groove. Compare the worn (upper) collar with the unworn collar below. Right: The hairpin springs are easily removed by prising them out with a screwdriver

Wear usually occurs at the closed loops and the collar grooves. Always examine both closely. If there is more than just a light wear marking on a spring, replace it.

The easiest way to check on collar wear is to make a comparison with a new one.

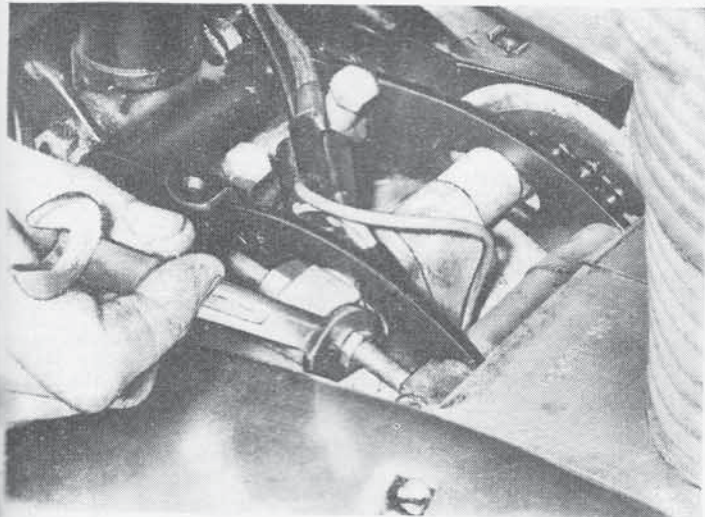
A COMMON fault on machines received by the AMC service department is incorrectly adjusted primary chains.

Primary chain adjustment is quite simple after removing the cover plate on top of the gear box. The two clamping bolts can be seen in the picture

Now you can go ahead and set the adjustment. Correct slackness is $\frac{1}{8}$ in at the tightest point. This can be checked after removing the inspection cap in the outer half of the primary chaincase.

The drill is quite simple. Undo the two screws retaining the metal cover on top of the gear box. Slacken the two bolts (at the rear of the box) which tension the retaining

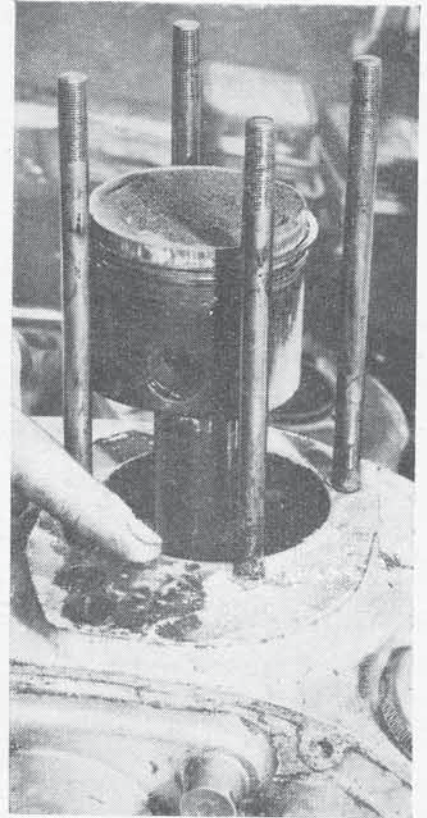
Too liberal use of jointing compound at the cylinder-base joint can result in the oilway to the valve gear becoming blocked when the cylinder is tightened down

The centre stand will not support the machine safely if wear on the stop for each leg permits it to move too far forward

For instance, if the cylinder-base joint is smeared too liberally there is the risk of the oilway to the rocker gear being blocked by compound forced into it as the cylinder barrel is tightened down.

IF the centre stand will not support the machine safely it is probably because both wheels are touching the ground. This happens when wear on the stop for each leg permits the legs to move too far forward. The repair dodge is to build up the stops by welding.
