Fettling AJS and MATCHLESS Two-fifties

SERVICE-
SHOP
LORE
No 13

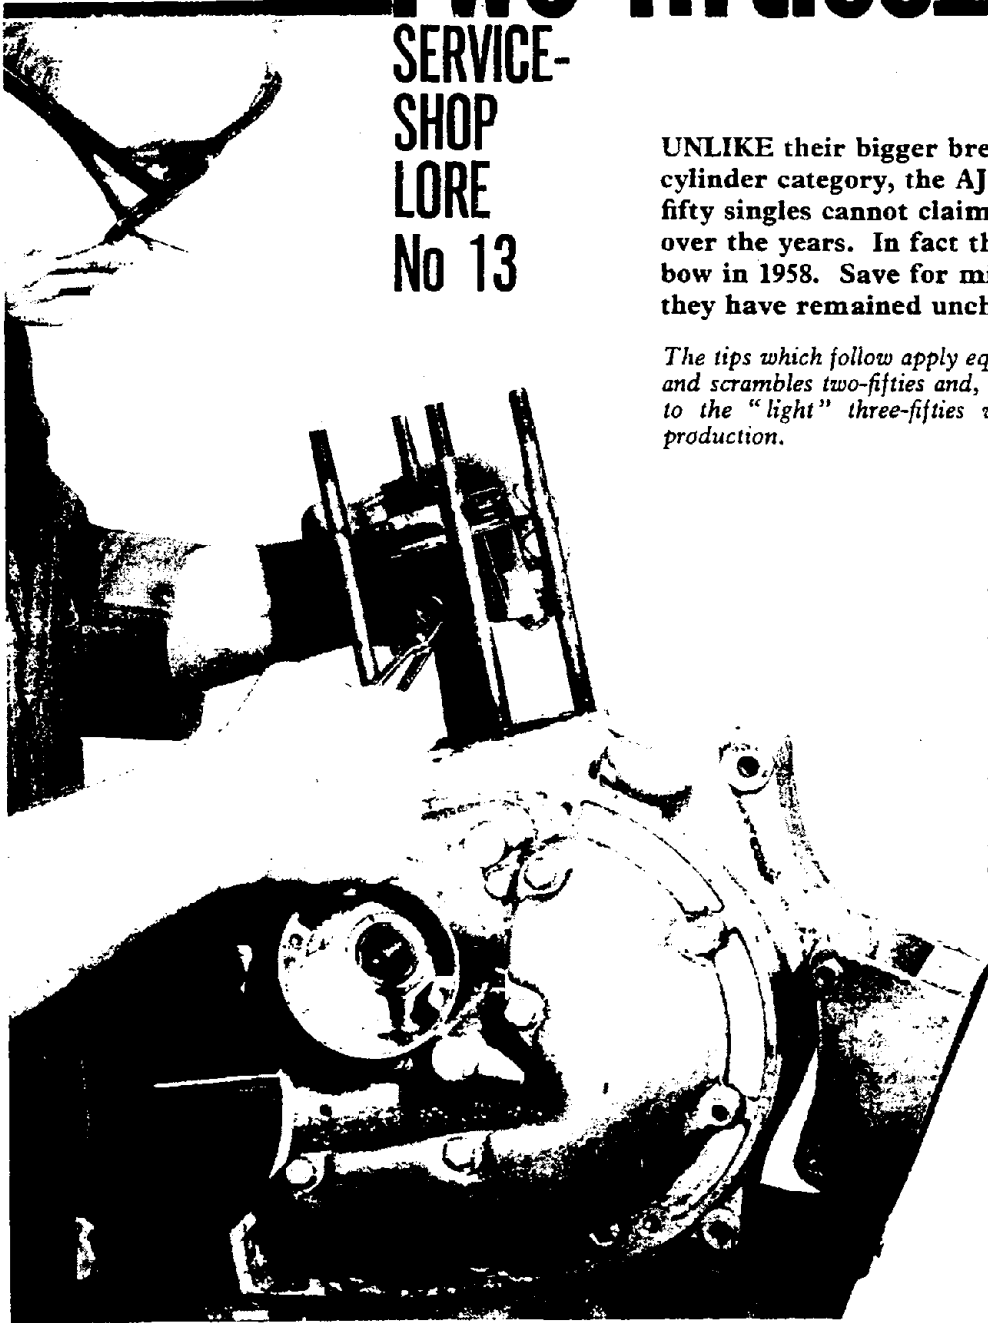
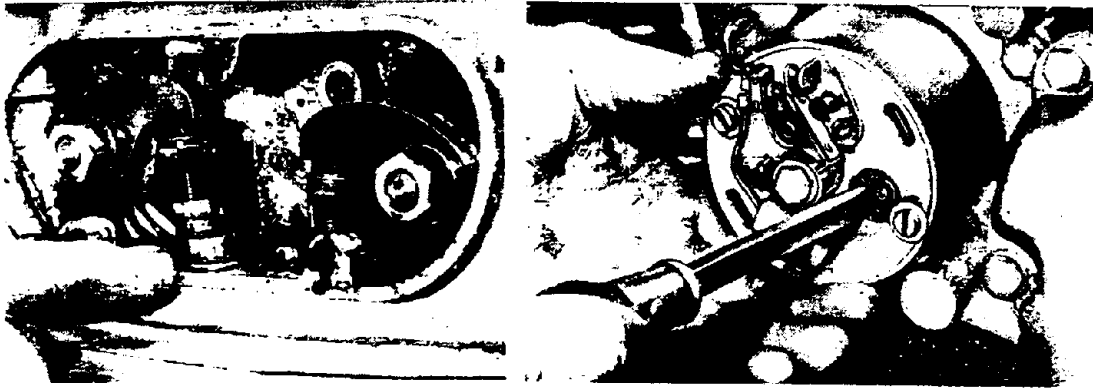
WHEN removing the rocker box set the piston at about top dead centre with both valves closed; and remember that one retaining bolt cannot be reached until the inspection cover has been taken off.

Left: Indicated is the rocker box retaining bolt which sometimes gets forgotten. The inlet valve is shown open. Both valves should be closed before attempting to remove the rocker box. Right: Before setting the timing, the bob-weights should be held in the advanced position

ALWAYS set the ignition timing with the automatic device in the full-advance position.

The drill, therefore, is to lock the cam on full advance. To do this you remove the securing bolt and thread on to it a 3/16in-thick collar counterbored to clear the spindle end and bear against the cam.

Then, holding the bob-weights at full advance with the screwdriver, you have only to tighten the bolt lightly to lock the cam against the spindle shoulder behind it.

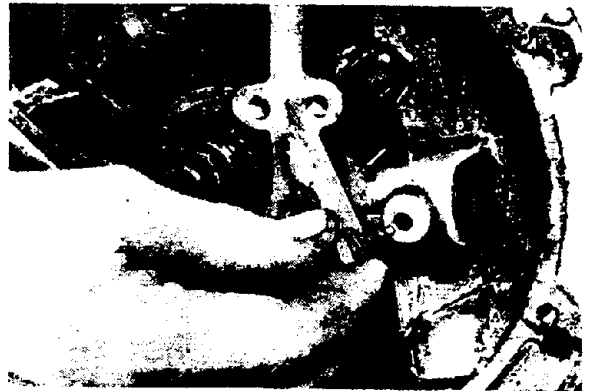
by a guide pin which engages in a profiled groove in the plunger. Wear on this guide pin, even to a very small degree, will affect the action of the plunger.

There is no need to remove this stud when the pump is being dismantled. Some owners do so, however, and occasionally fail to engage the pip with the groove.

The result is that as soon as the engine is started oil pressure dislodges the cap, pressure is lost and the lubrication system fails.

Left: Wear on the end of the guide pin which engages in the profiled groove of the pump plunger will cause loss of efficiency. Right: When dismantling the oil pump there is no need to disturb this stud which merely retains a blanking cap

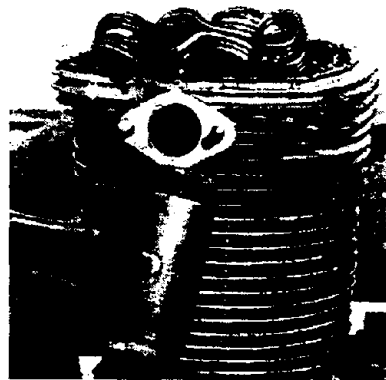
If the head is difficult to remove and it is necessary to use a hide mallet, the correct place is beneath the carburettor mounting flange

TO free the cylinder head sometimes calls for a little persuasion with a hide or plastic-face mallet. Best place to do the tapping is under the induction tract.

This has plenty of metal supporting it and there is no risk of inadvertently clouting the cylinder-head or barrel fins.

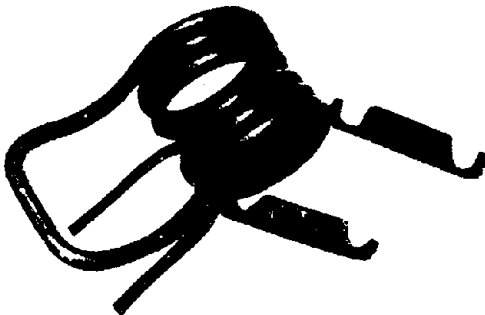
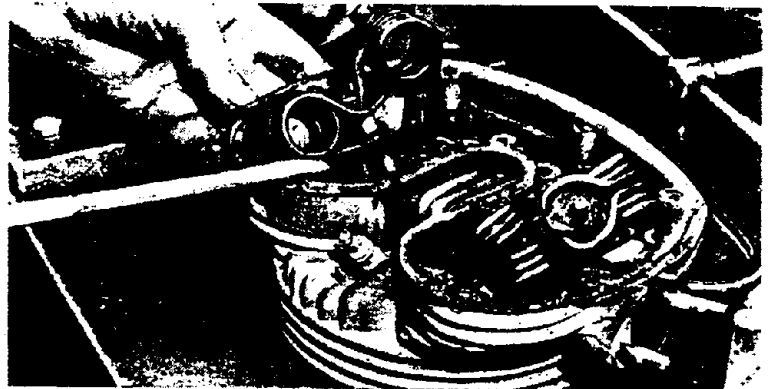
Above: Wear on the closed loops of the valve spring occurs where it engages with the collar groove. Compare the worn (upper) collar with the unworn collar below. Right: The hairpin springs are easily removed by prising them out with a screwdriver

Wear usually occurs at the closed loops and the collar grooves. Always examine both closely. If there is more than just a light wear marking on a spring, replace it.

The easiest way to check on collar wear is to make a comparison with a new one.

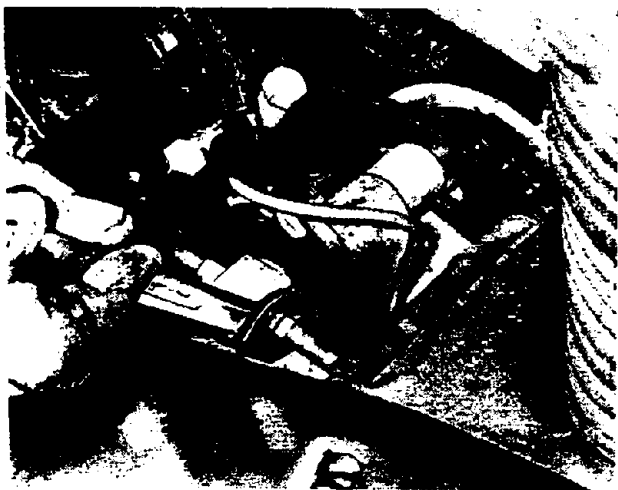
Too liberal use of jointing compound at the cylinder-base joint can result in the oilway to the valve gear becoming blocked when the cylinder is tightened down

For instance, if the cylinder-base joint is smeared too liberally there is the risk of the oilway to the rocker gear being blocked by compound forced into it as the cylinder barrel is tightened down.

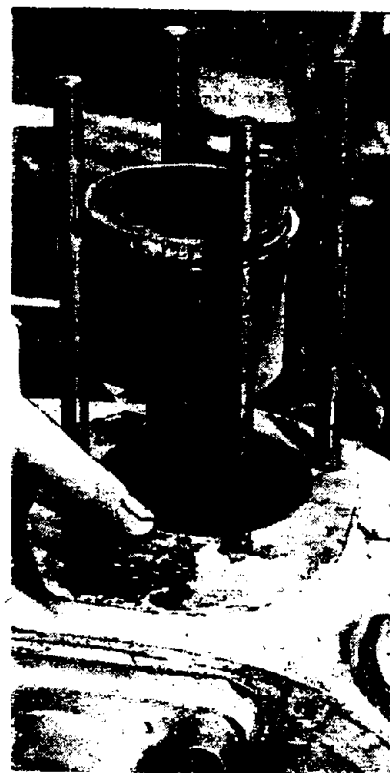
A COMMON fault on machines received by the AMC service department is incorrectly adjusted primary chains.

Primary chain adjustment is quite simple after removing the cover plate on top of the gear box. The two clamping bolts can be seen in the picture

Now you can go ahead and set the adjustment. Correct slackness is $\frac{1}{16}$ in at the tightest point. This can be checked after removing the inspection cap in the outer half of the primary chaincase.

The drill is quite simple. Undo the two screws retaining the metal cover on top of the gear box. Slacken the two bolts (at the rear of the box) which tension the retaining
