AJS/Matchless Heavyweight Rear Hub, speedometer side assembly sequence

Assembly of the Speedometer side of the rear hub of a '56 G-11. This was done with assistance of the Jampot Article from January 1998 titled "The Heavyweight Rear Hub" by C.G., edited by Chris Read as well as moral support from Mark Siebert and Pete "the cheap". Since I had difficulties in getting mine assembled correctly, I thought I'd take the time to make a web page out of it for others to share.

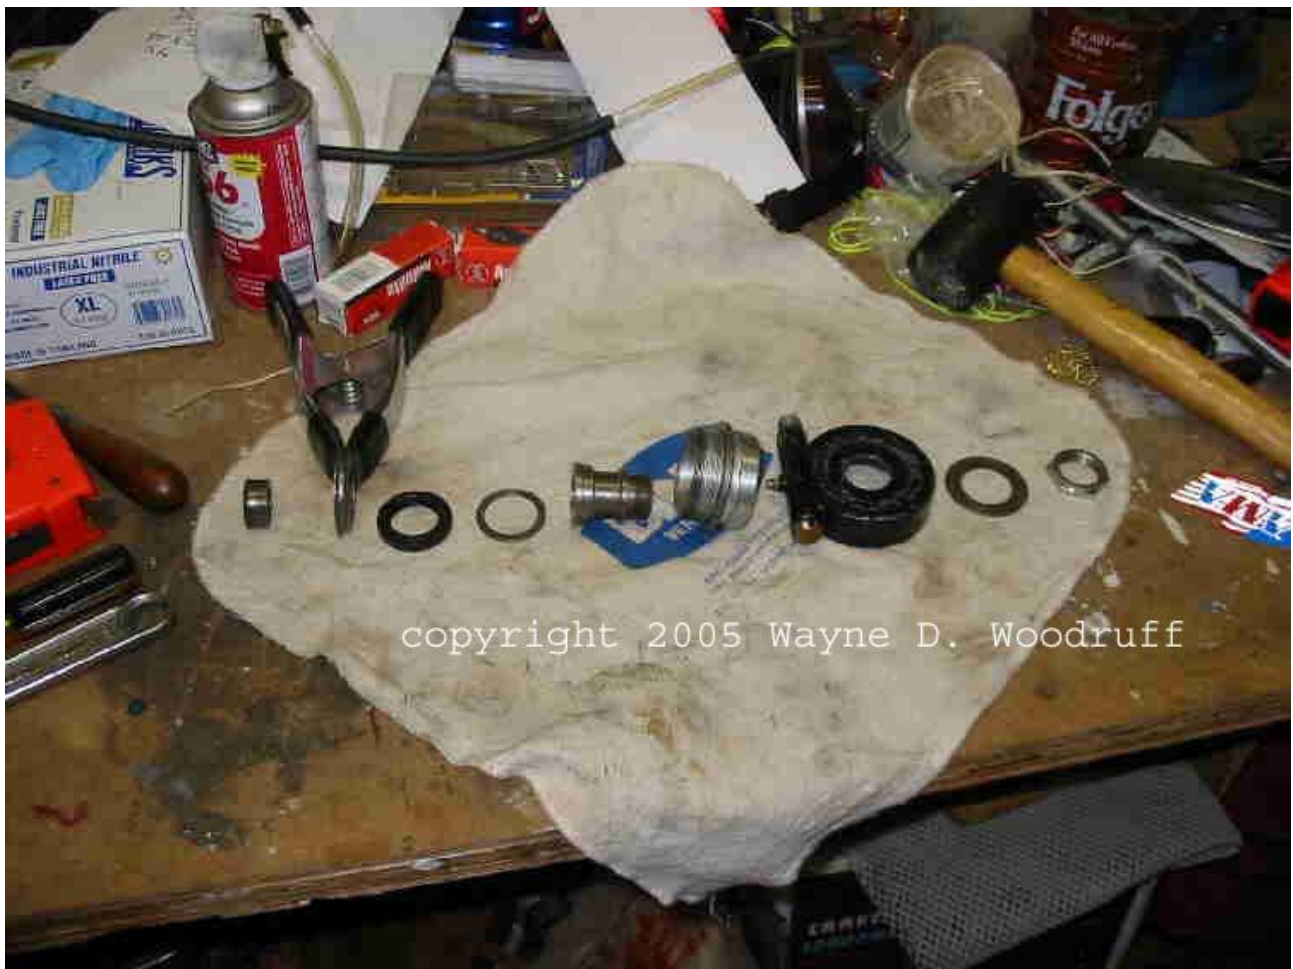
Fig 1: All parts laid out in the proper sequence and proper orientation. Pay particular attention to the orientation of the seal cup (2nd part from the left). The "wide" side faces AWAY from the seal!

Matchless part numbers from left to right:

- 021608 - spacer, on rear wheel solid spindle, for oil seal
- 018094 - Cup, for rear hub bearing oil-seal
- 014387 - Oil-seal, for rear hub bearing
- 021585 - Ring, retaining, rear hub bearing oil seal (small)
- 021594 - Spacer on rear wheel spindle for speedo gear box
- 021583 - Ring, adjusting, for rear hub and 021584 - Nut, lock, for rear hub bearing adjusting ring shown together
- speedo drive
- ??? washer for speedo drive
- 021593 - Nut, locking, speedometer gearbox

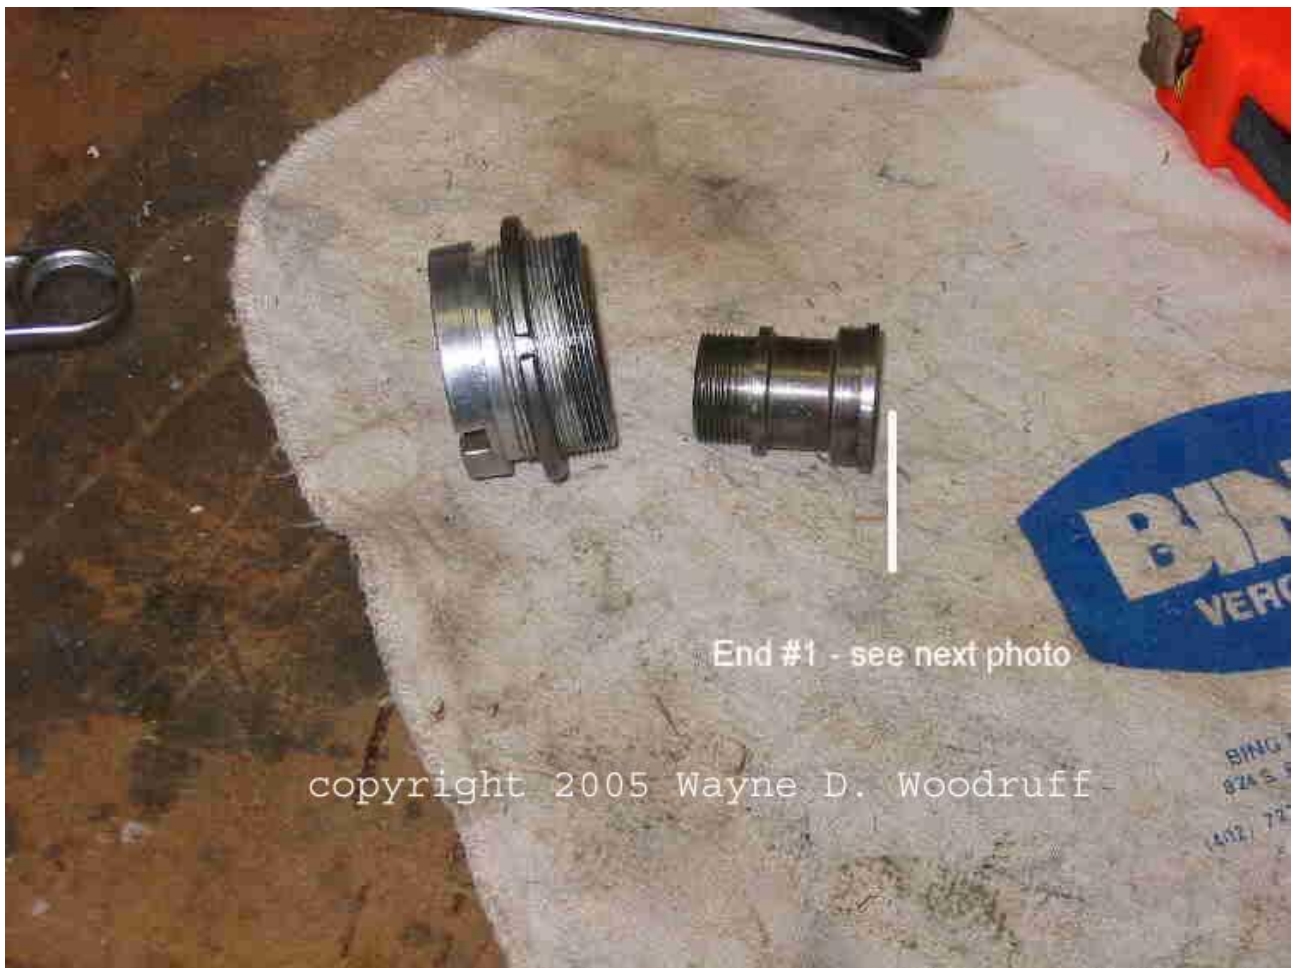
Fig 2: The threaded axle the the speedo drive attaches to as about to be inserted in the retaining ring

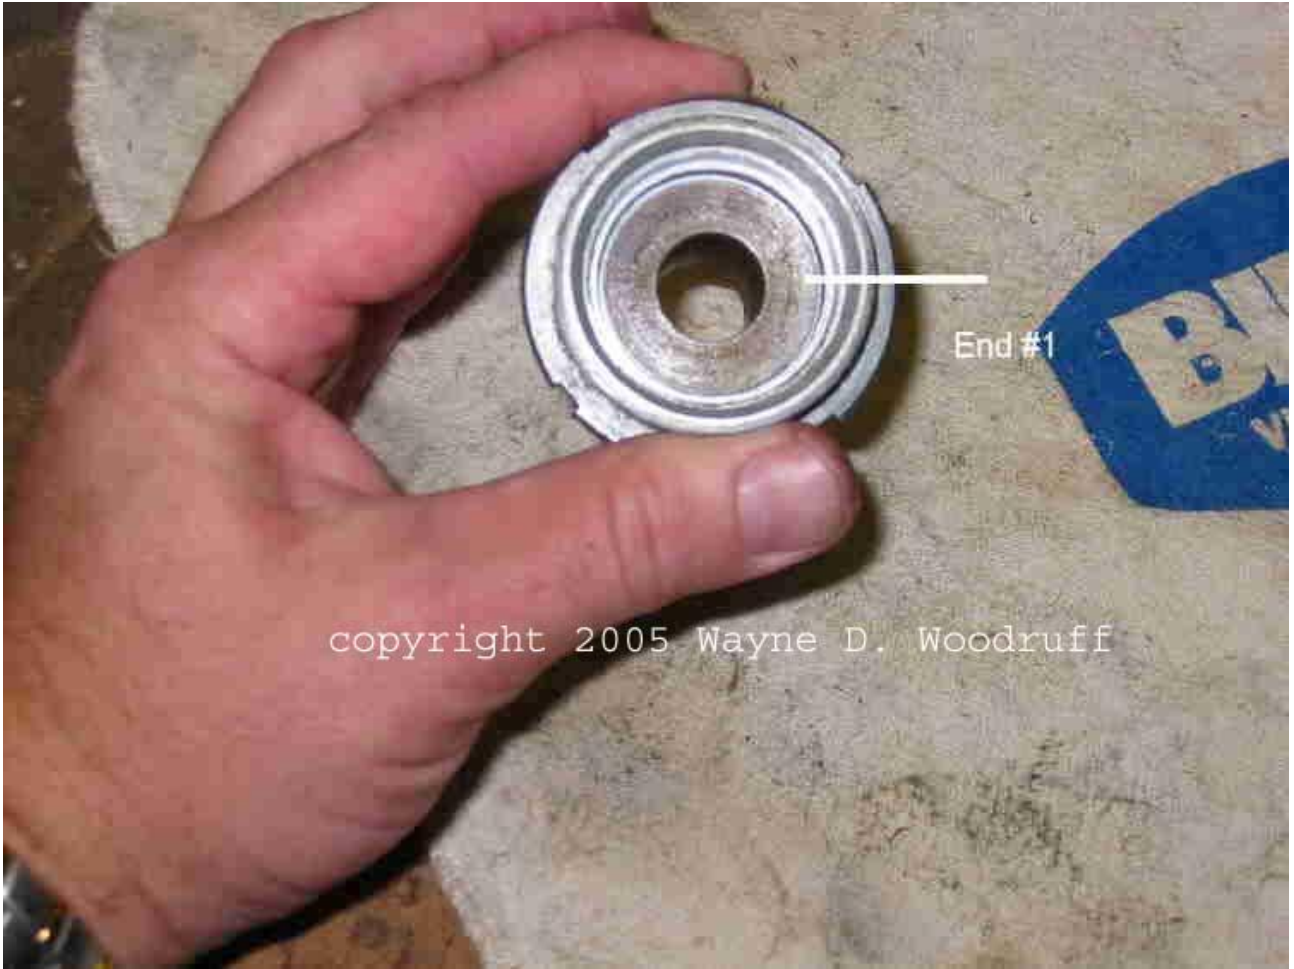
Fig 3: End view of Fig 2. The threaded axle now rests in the seat

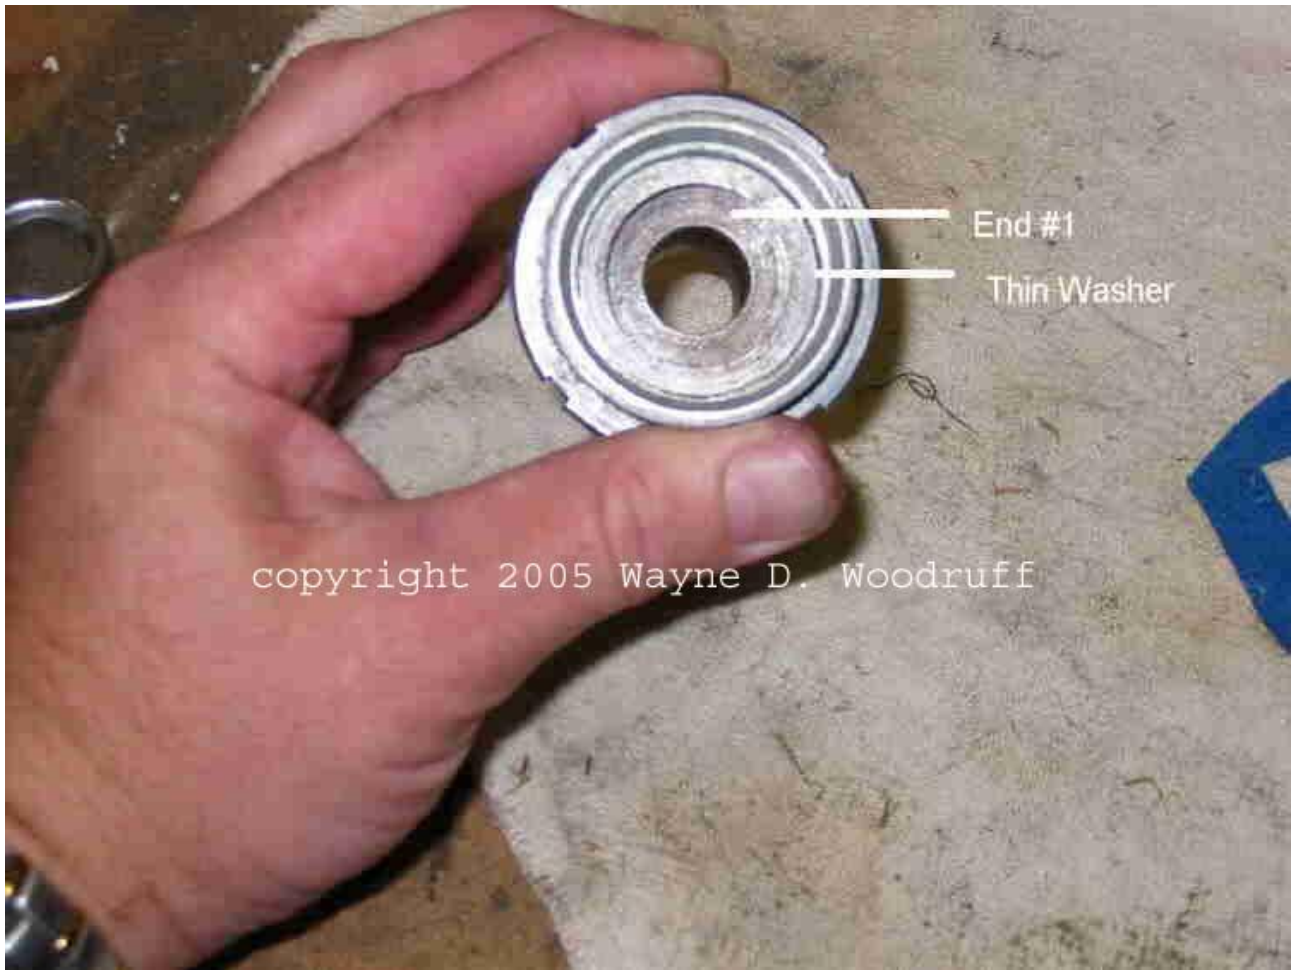
Fig 4: The thin washer (4th from left in 1st photo) now in place

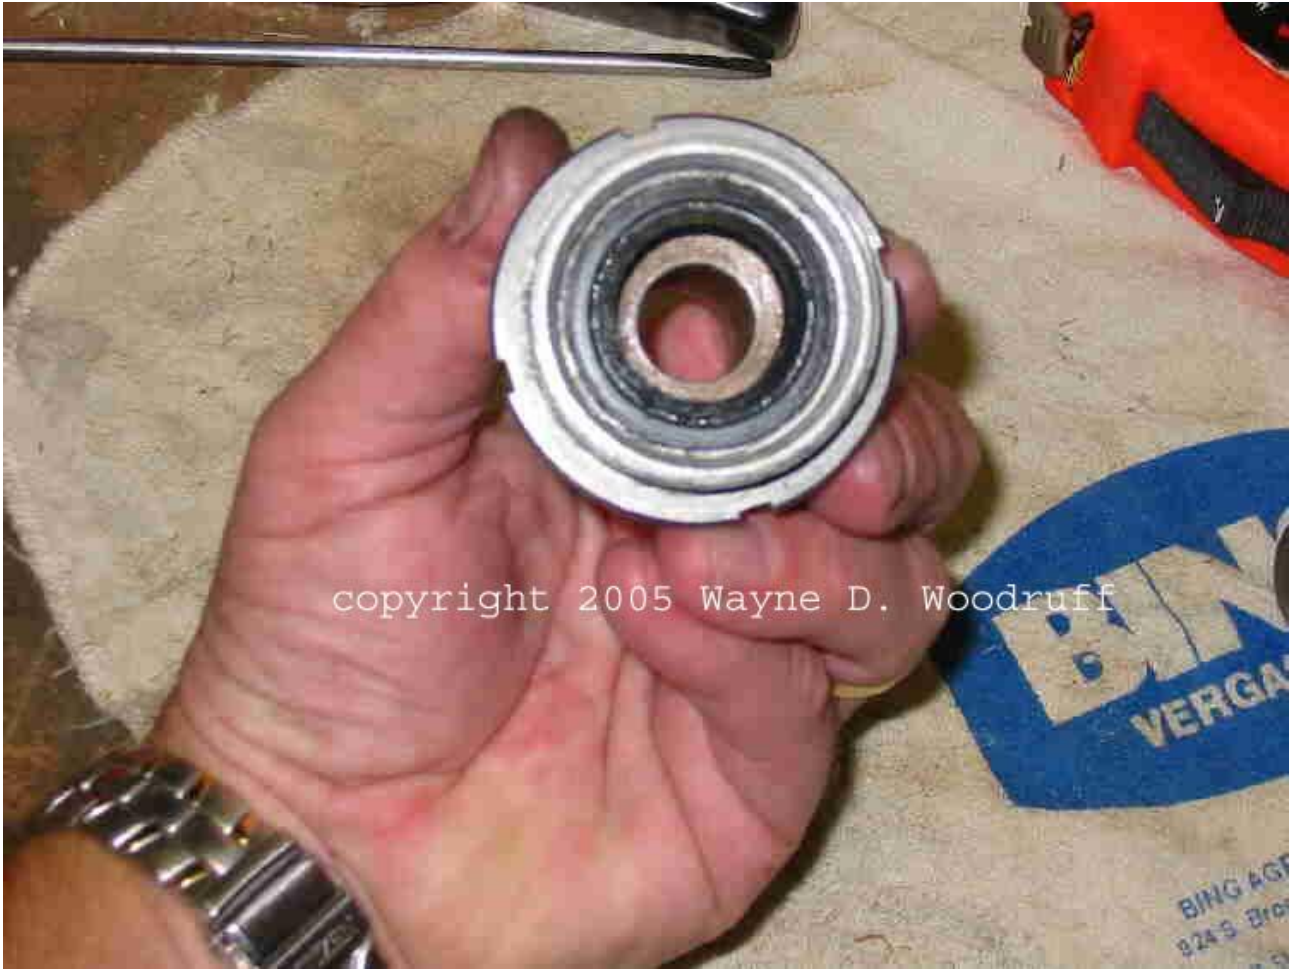
Fig 5: Rubber (or felt) seal now in place. You must work this to fit within the opening in the housing.

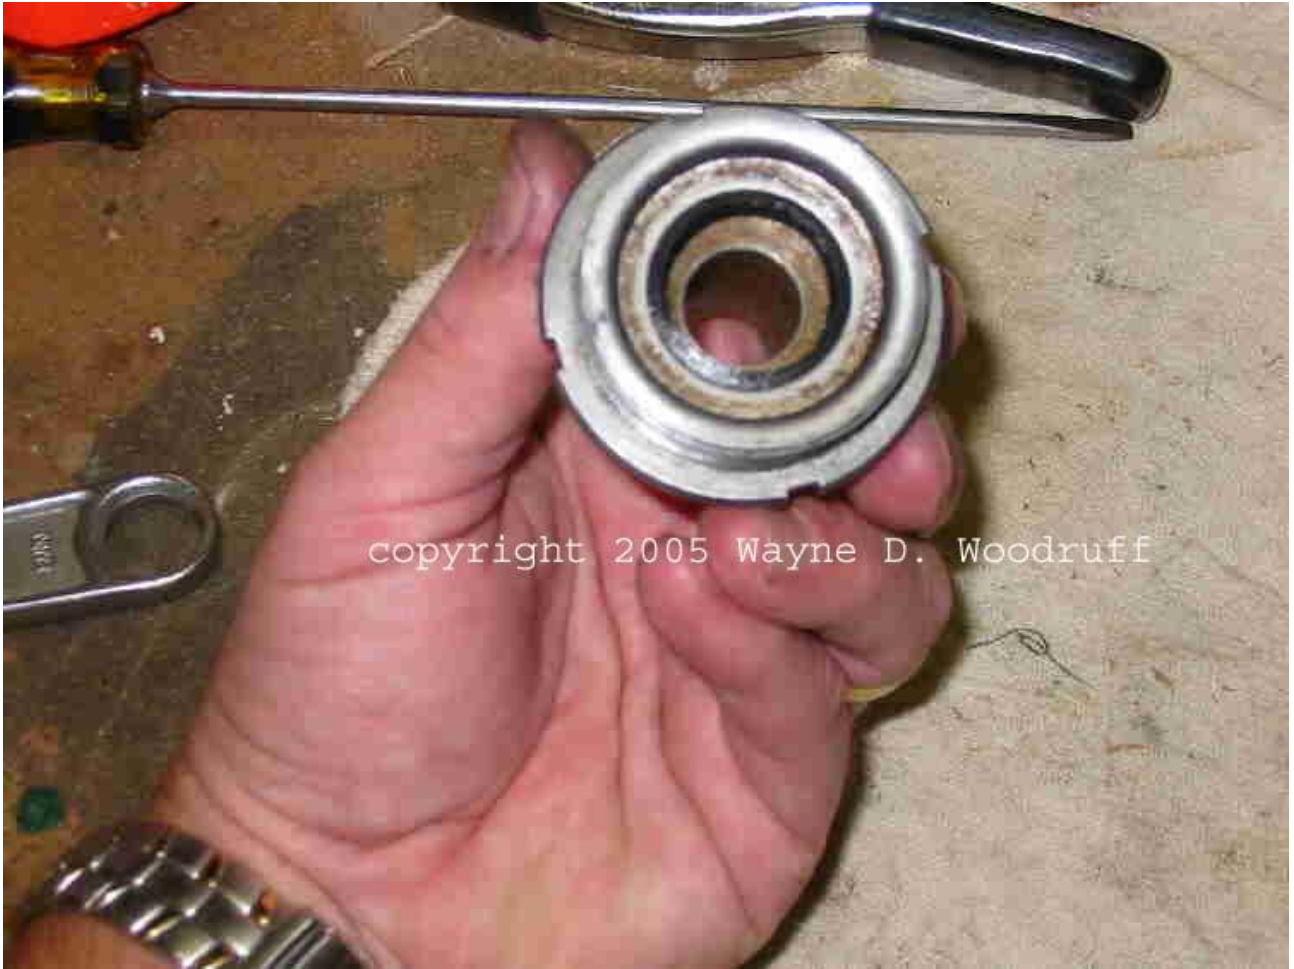
Fig 6: Cup in place (2nd part from left in photo #1). Again, note the orientation of the cup. **This orientation is critical!!** The "narrow" side faces the oil seal.

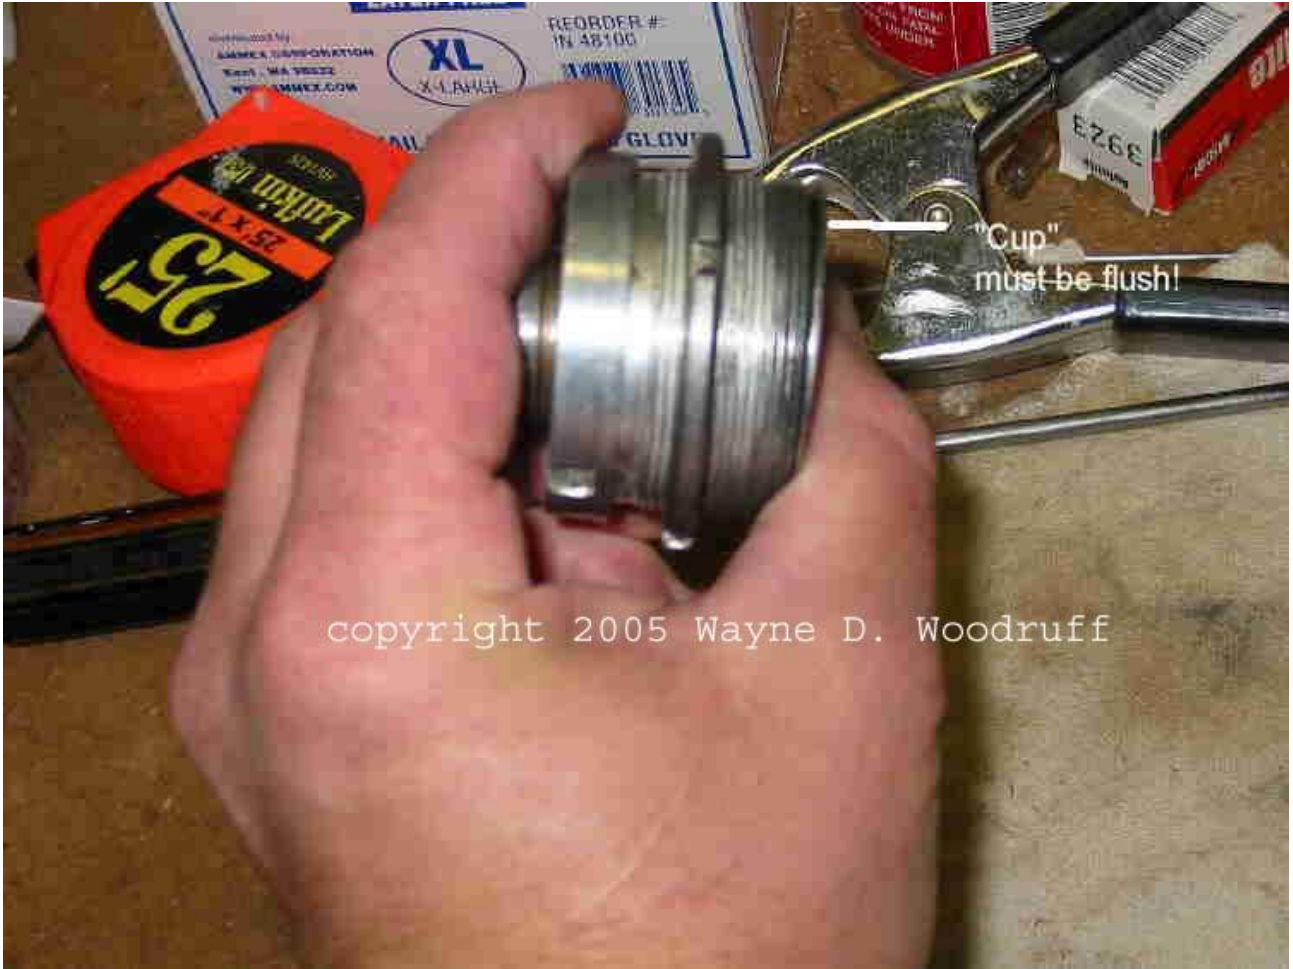
Fig 7: Side view of Fig 6 - showing cup MUST BE FLUSH with housing!

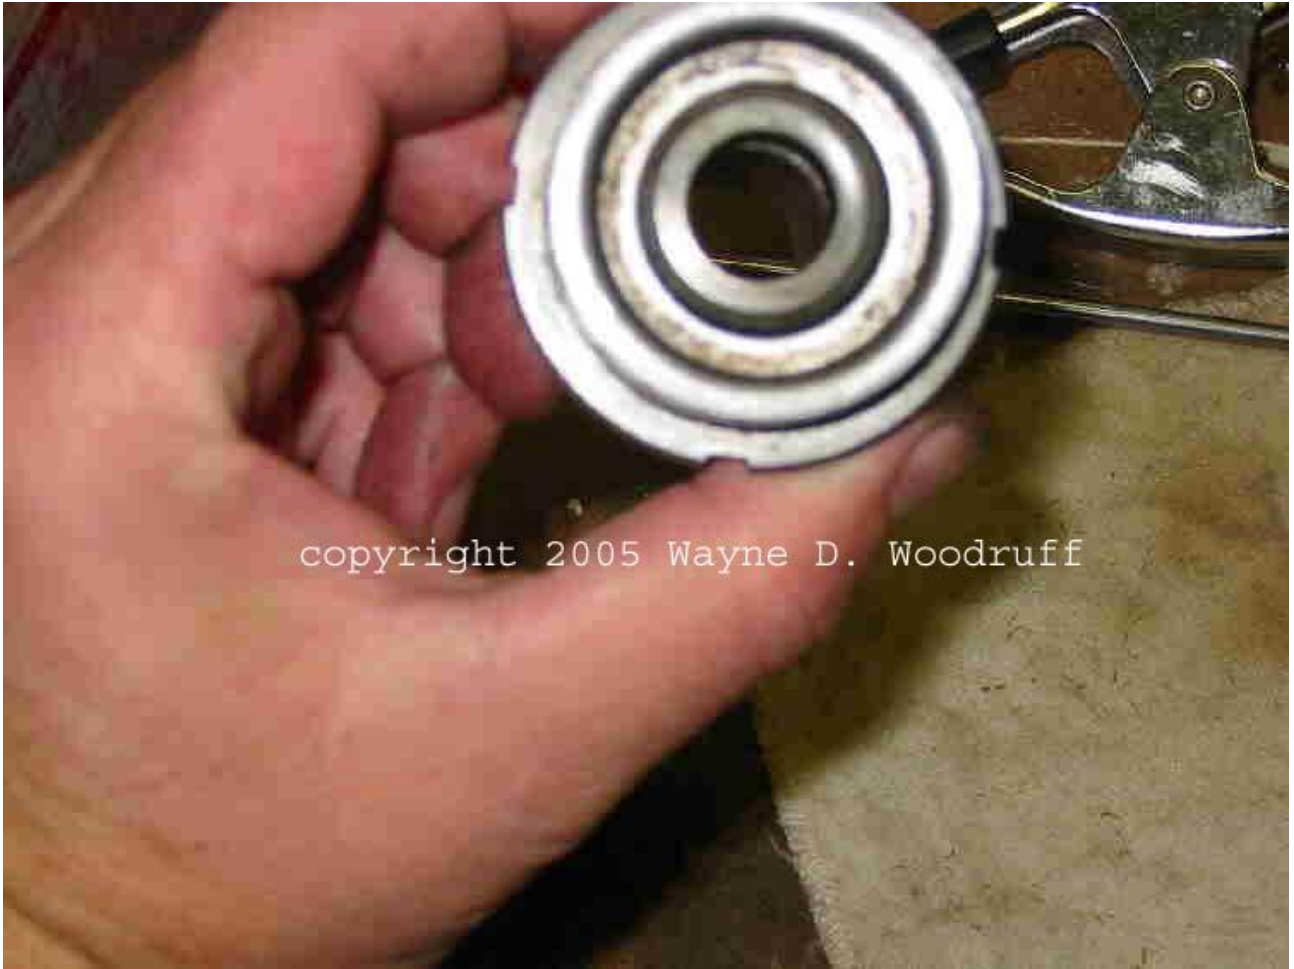
Fig 8: Added spacer (left-most item from photo #1)

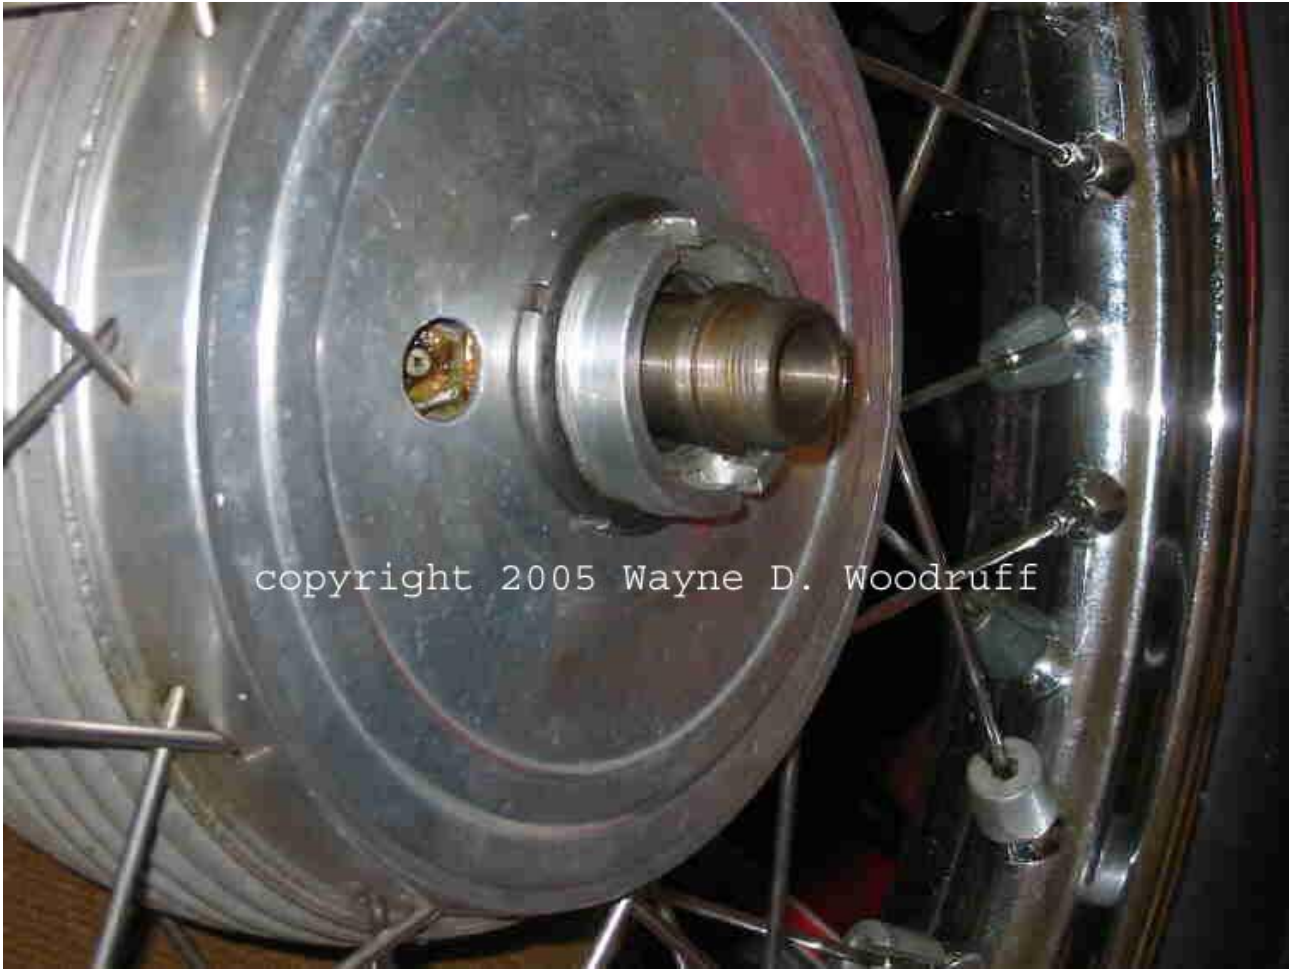
Fig 9: Adjusting nut installed in hub and locking ring tightened. NOTE ... I USED LOCTITE RED ON THE LOCKING RING. I had lots of problems keeping this ring locked without it

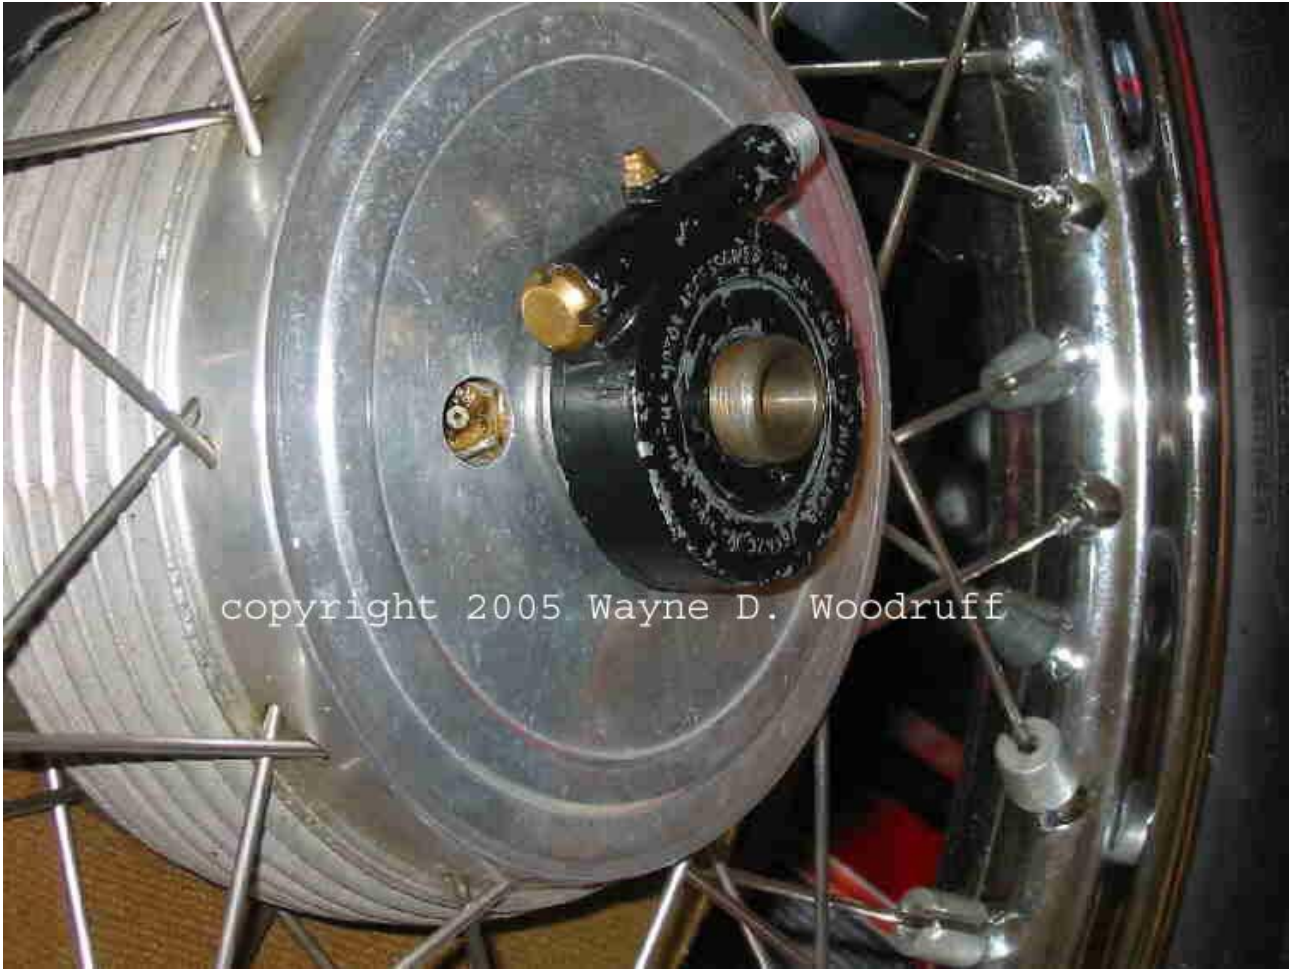
Fig 10: Speedo drive installed

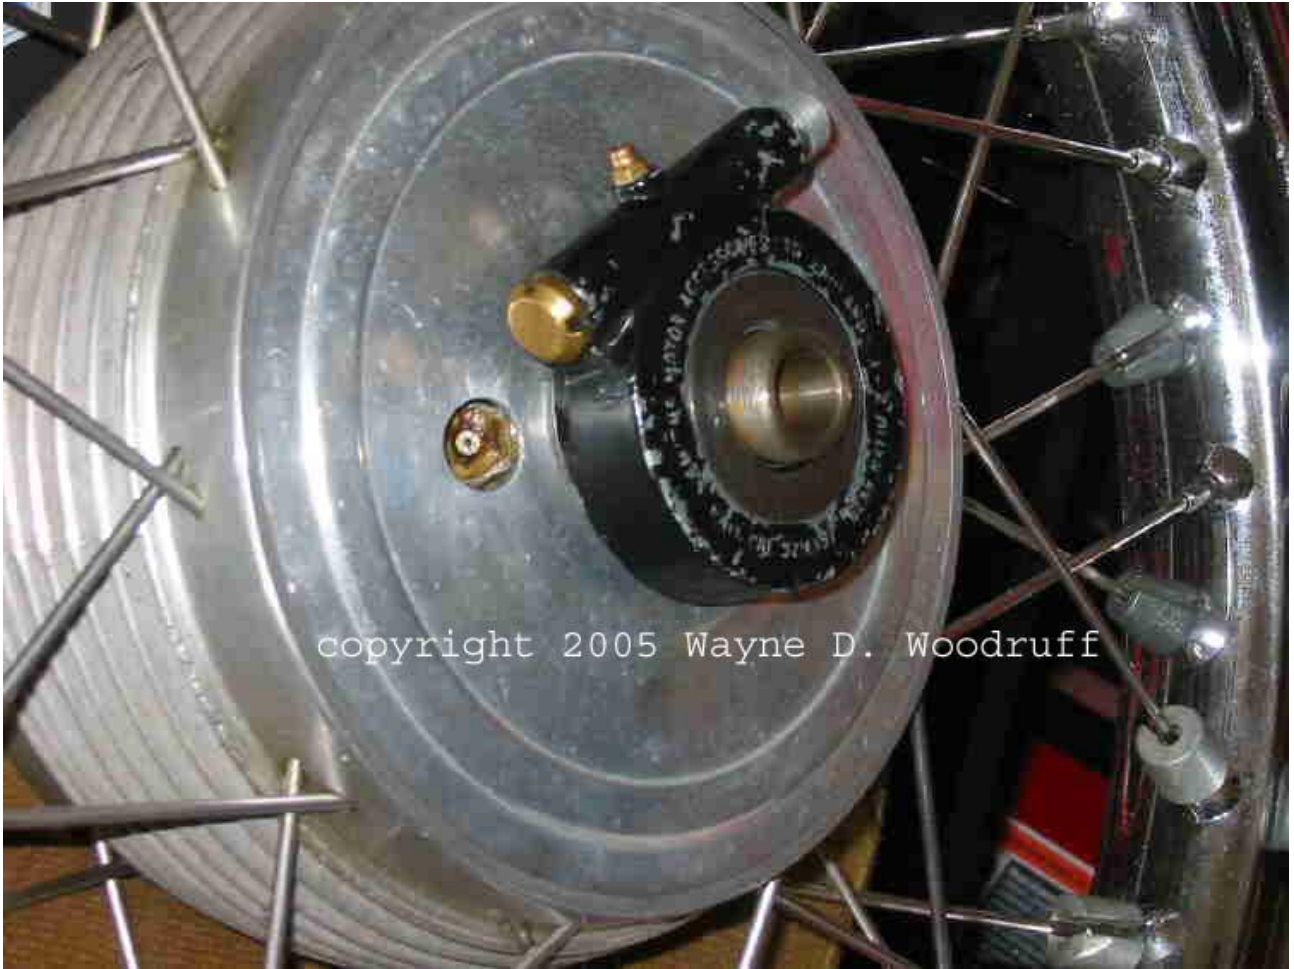
Fig 11: Speedo drive installed with washer

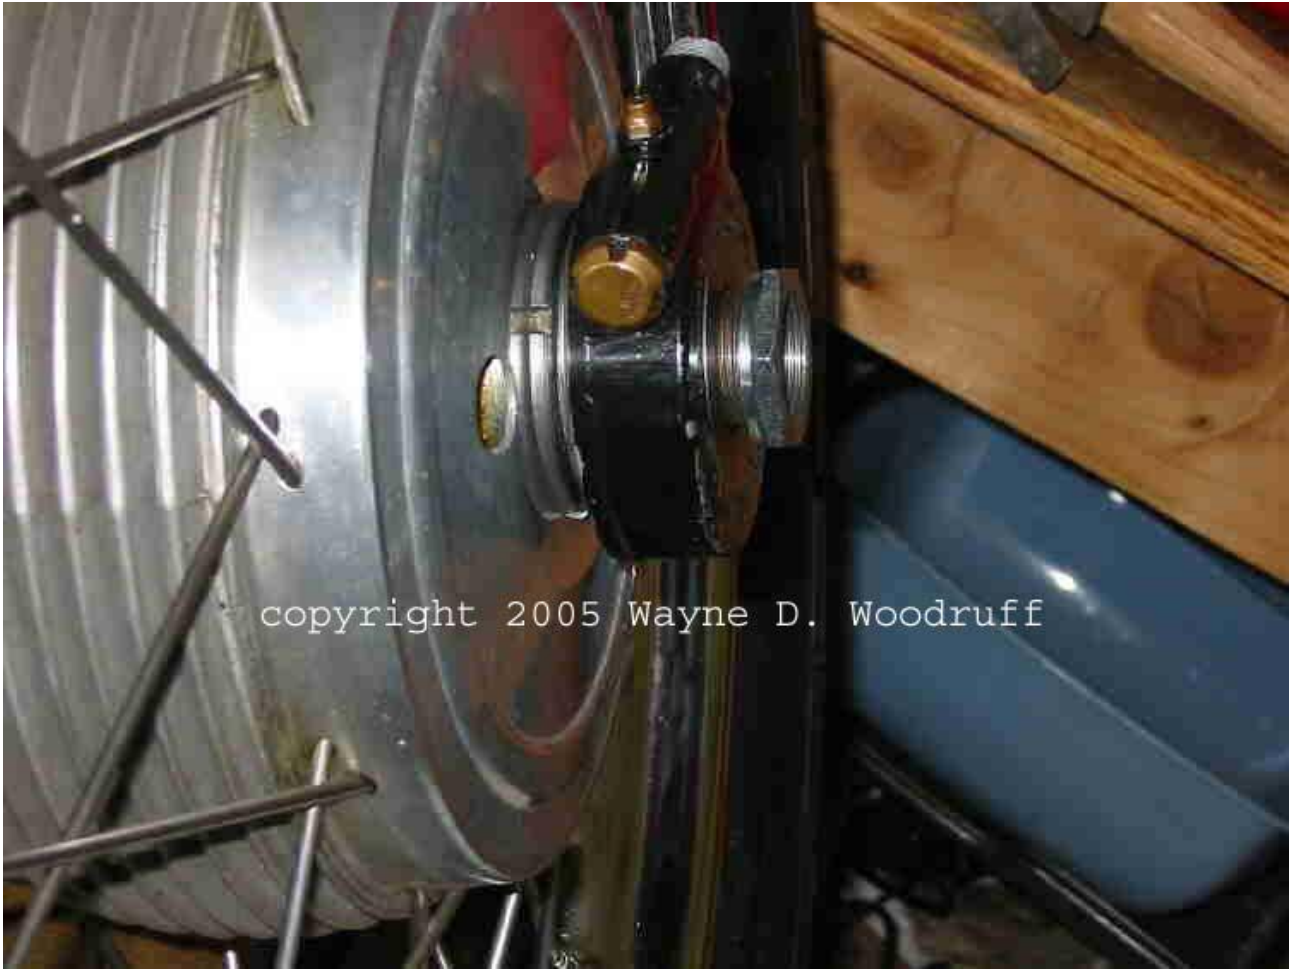
Fig 12: Speedo drive installed with washer and nut - note orientation of nut! The final tightening of the nut can be done with the wheel in place

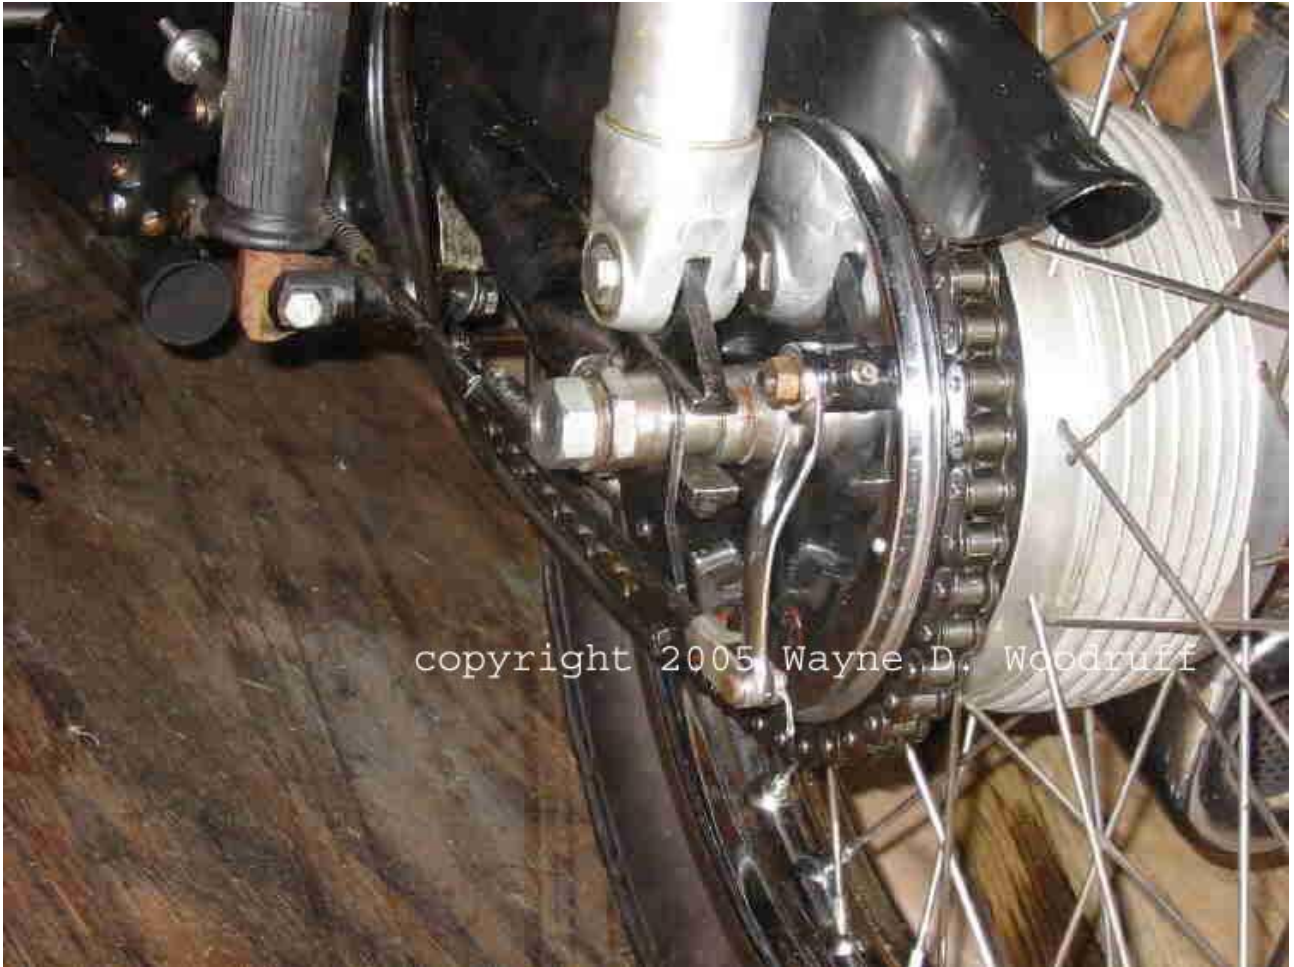
Fig 14: Left side of rear wheel showing all installed components
