THE 'CLASSIC MECHANICS' STRIPDOWN

# 1954 Matchless G3LS

Ken de Groome strips the long stroke 350 AMC engine

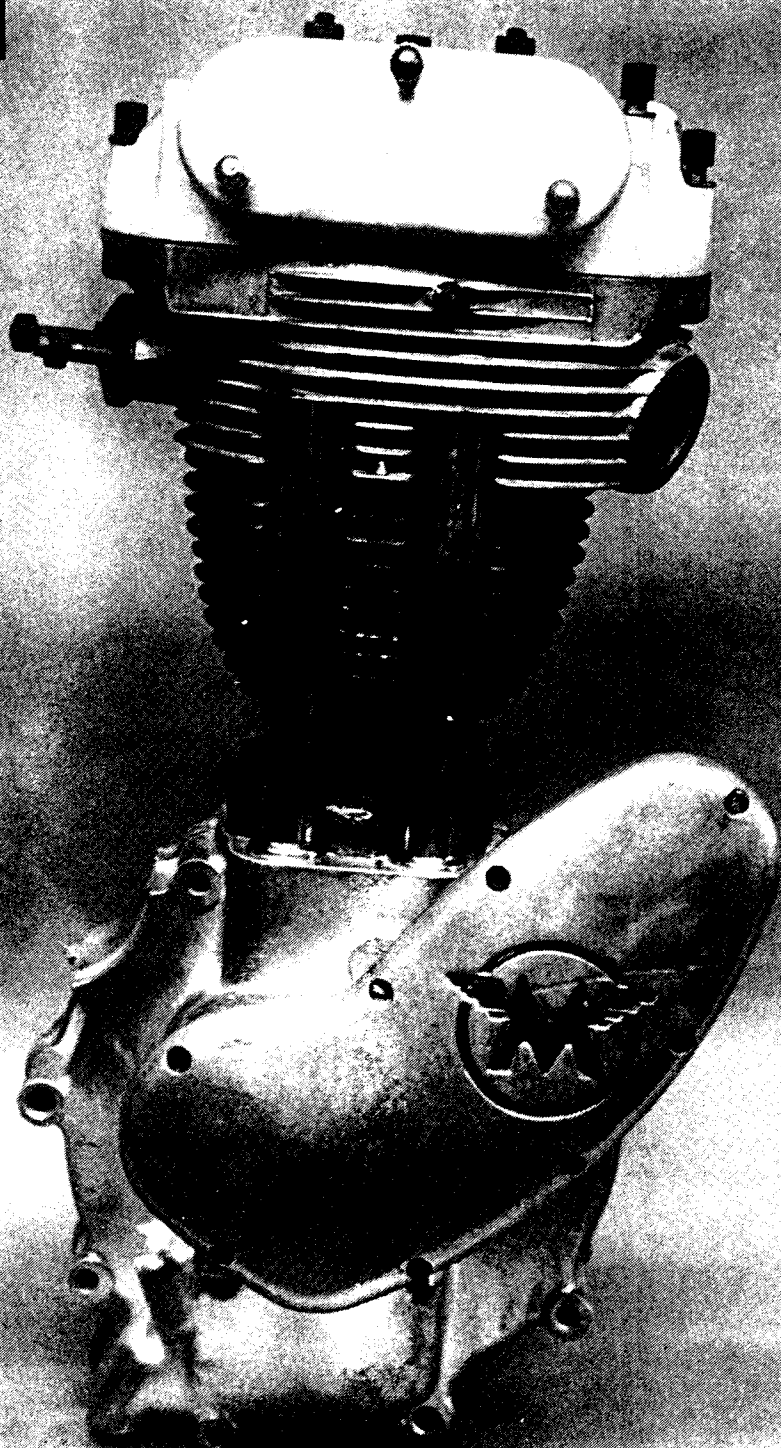
1

- Having removed engine from its chassis, you should end up with something that looks a bit like **pic one**. This engine came to me 'as seen' and minus its magneto but I will cover magneto sprocket removal later so don't panic yet if you can't get yours off!

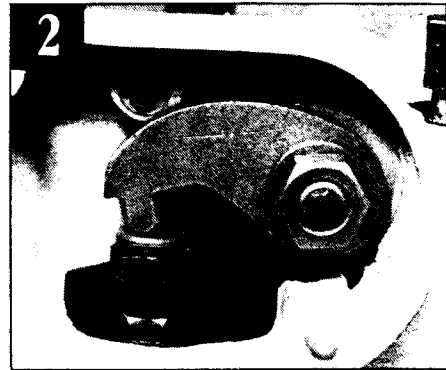
2

crankshaft to get the engine at about TDC on the compression stroke. The object of doing this is to remove any valve-spring pressure when removing the rocker-box. If your engine won't turn over because of a seizure or something, then slacken off the tappet adjusters as far as possible (**pic two**).

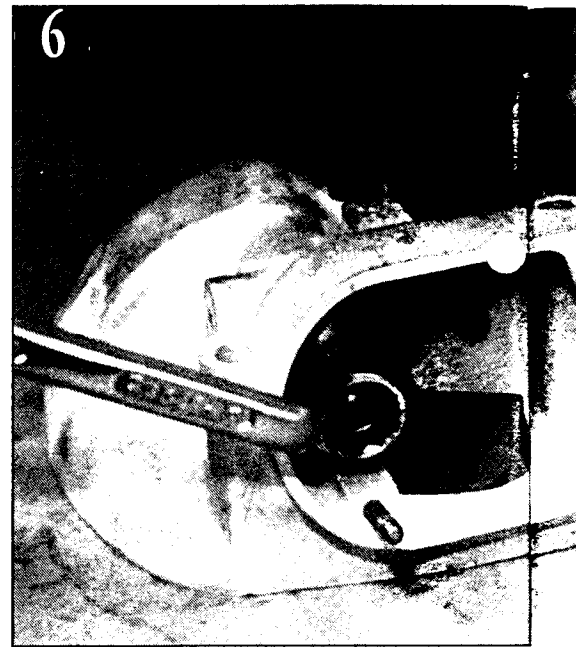
6

- To dismantle the rocker-gear, first slacken off the outer two nuts (**pic six**) a little, then with an open ended spanner, undo the

inner ones. It is then possible with just a little levering to pull the whole lot apart. If you found that you didn't use much effort in undoing the outer two nuts, then check the splines at both ends of the spindles for twist, the slightest sign of it warrants new spindles. When re-assembling, fit the valve-end rocker to each spindle first and tighten up the nut on each until about a half to one complete thread shows through at the end. Then attach the outermost rockers with their respective nuts and washers. Tighten up the outer nuts to around 35ft lbs, the inner nuts will now also be tight as a result of doing this.

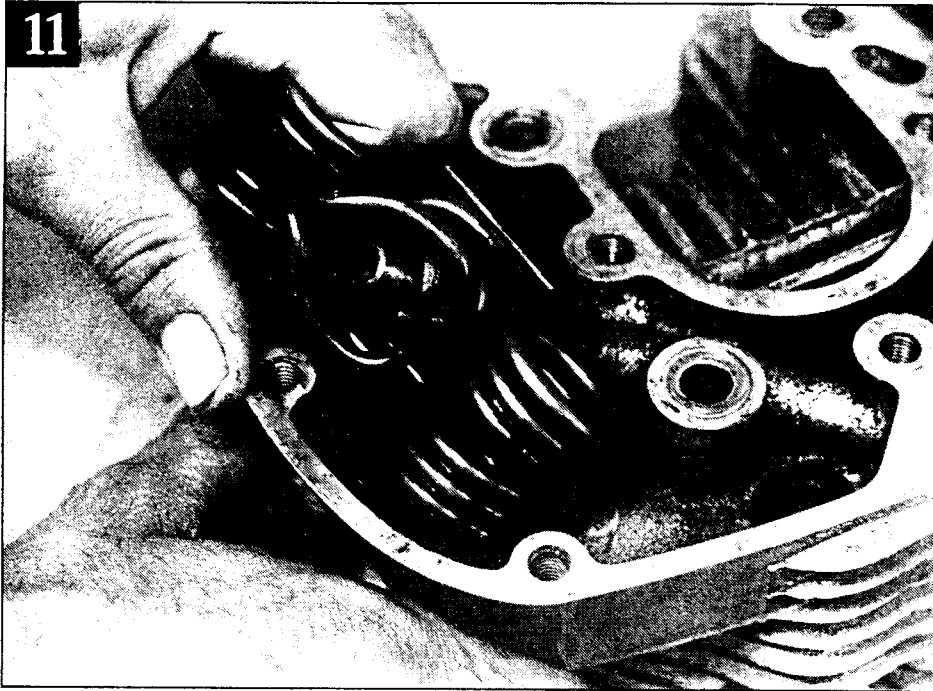
11

moon shaped one if the lower spring ends slide into a block, and a pressed steel 'scoop' affair for the later tray-type as illustrated in pic 10. Providing that you are reasonably strong (and careful) it is possible to remove and replace the later type by inserting an index finger through the coils (pic 11) and either pulling or pushing as required. It is quite easy but keep the elastoplast handy!

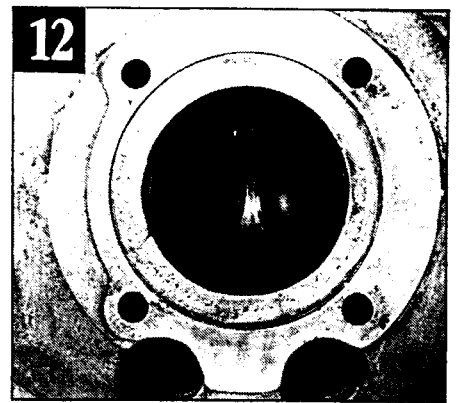
12

- The valves in this engine were quite 'pocketted' (pic 12) but as shown, are just about acceptable. Look carefully at both valve seats to see if they have moved within the head casting or are cracked – most problems seem to concern 350cc inlet seats and 500cc exhaust seats. If any of the above problems show up, then either find another head or get a new seat fitted. Fitting new seats to AMC heads is a bit tricky as they are cast-in during manufacture and quite a large hole has to be machined in the head to take a new seat (pic 13).

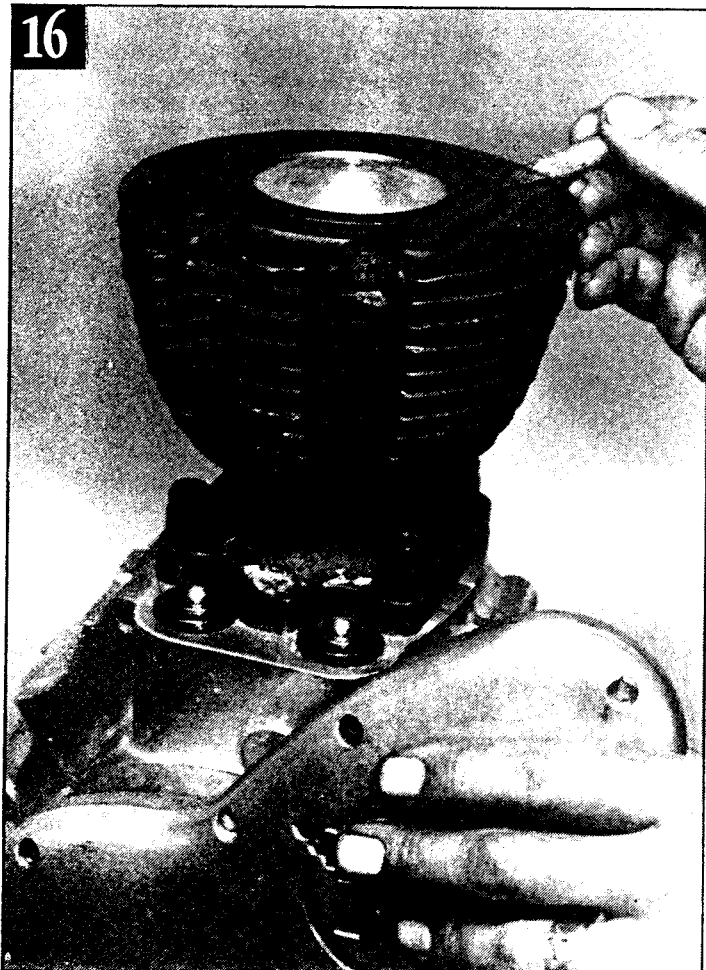
16

- The cylinder barrel is the next item to be removed – but first, if it is still attached, remove the head gasket (pic 16) carefully as it can be annealed and re-used if so desired.

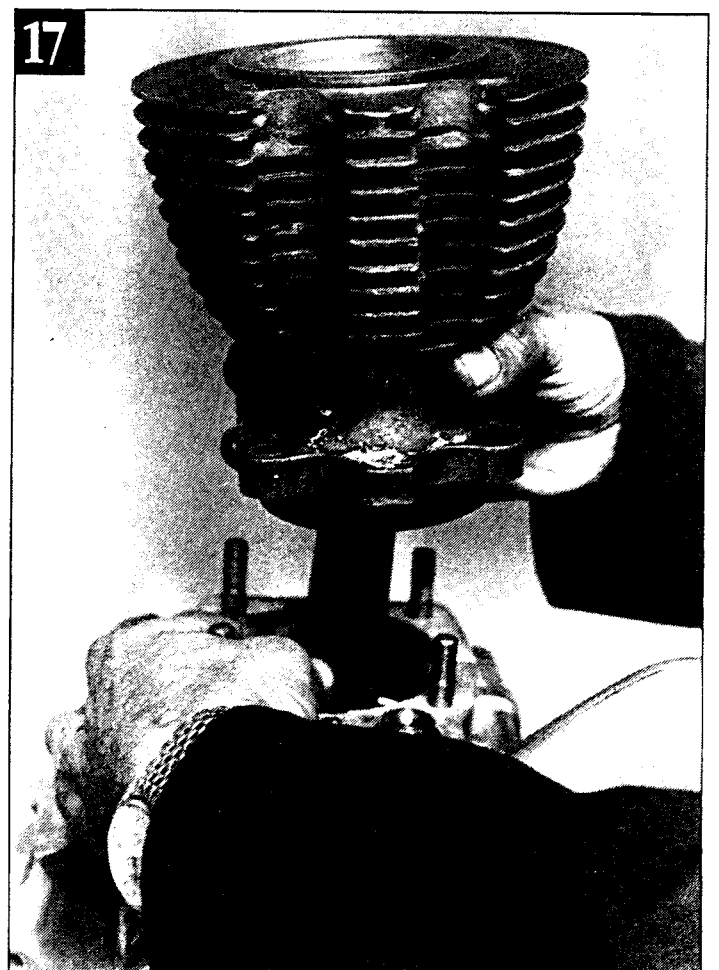
17

- Slackening the top two crankcase studs rarely makes much difference in releasing the barrel on these motors, owing to the large clearance between the barrel and crankcase mouth. If you don't plan on stripping the bottom-end, lift the cylinder a little way (pic 17) and place a clean rag around the crankcase mouth to catch any broken rings, etc. Otherwise just lift clear of the piston, being careful not to let the conrod
