SERVICE NOTES

AMC HEAVYWEIGHT SINGLES AJS and Matchless expert KEN BRYANT on the popular plonkers.

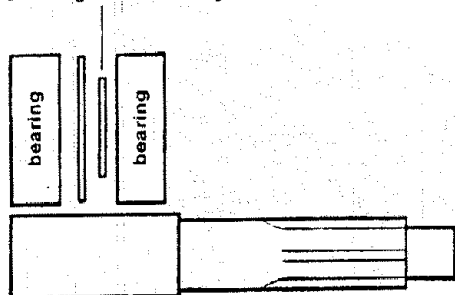
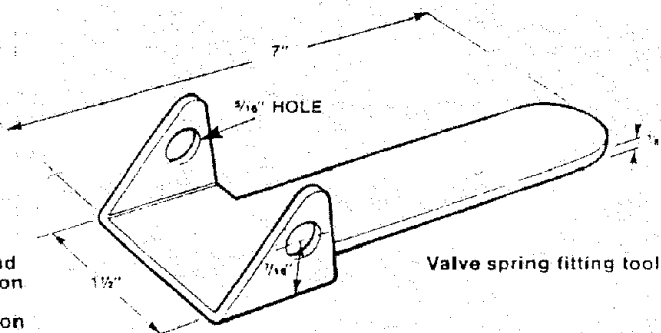
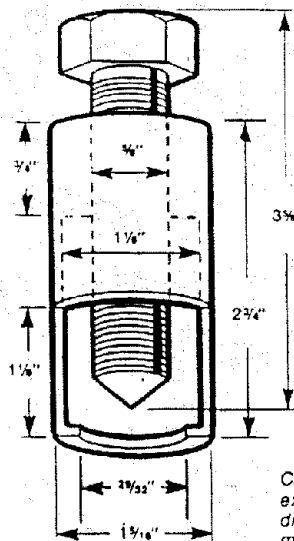
Pushrod tube seals and washers. Use B, C, D on W-D and 350cc up to 1948, with compression plate. On 1950-52 350cc use B, C. 500cc - A, B, C. On 1952 on, B, C.

Arrangement of main bearings and spacers. This spacer omitted on engines using one small and one large ball bearing on drive side, 1955 on.
