Burman Gearbox restoration (part one) GB 1953 Ariel VH 500 by George Torrens

The following information is the collective advice and my experience of refurbishing the Burman gearbox on my 1953 VH 500 single, reference GB6 G52 [940] C791. The bike is modelled by my wife, Amanda with dogs Peat and Moss in attendance.

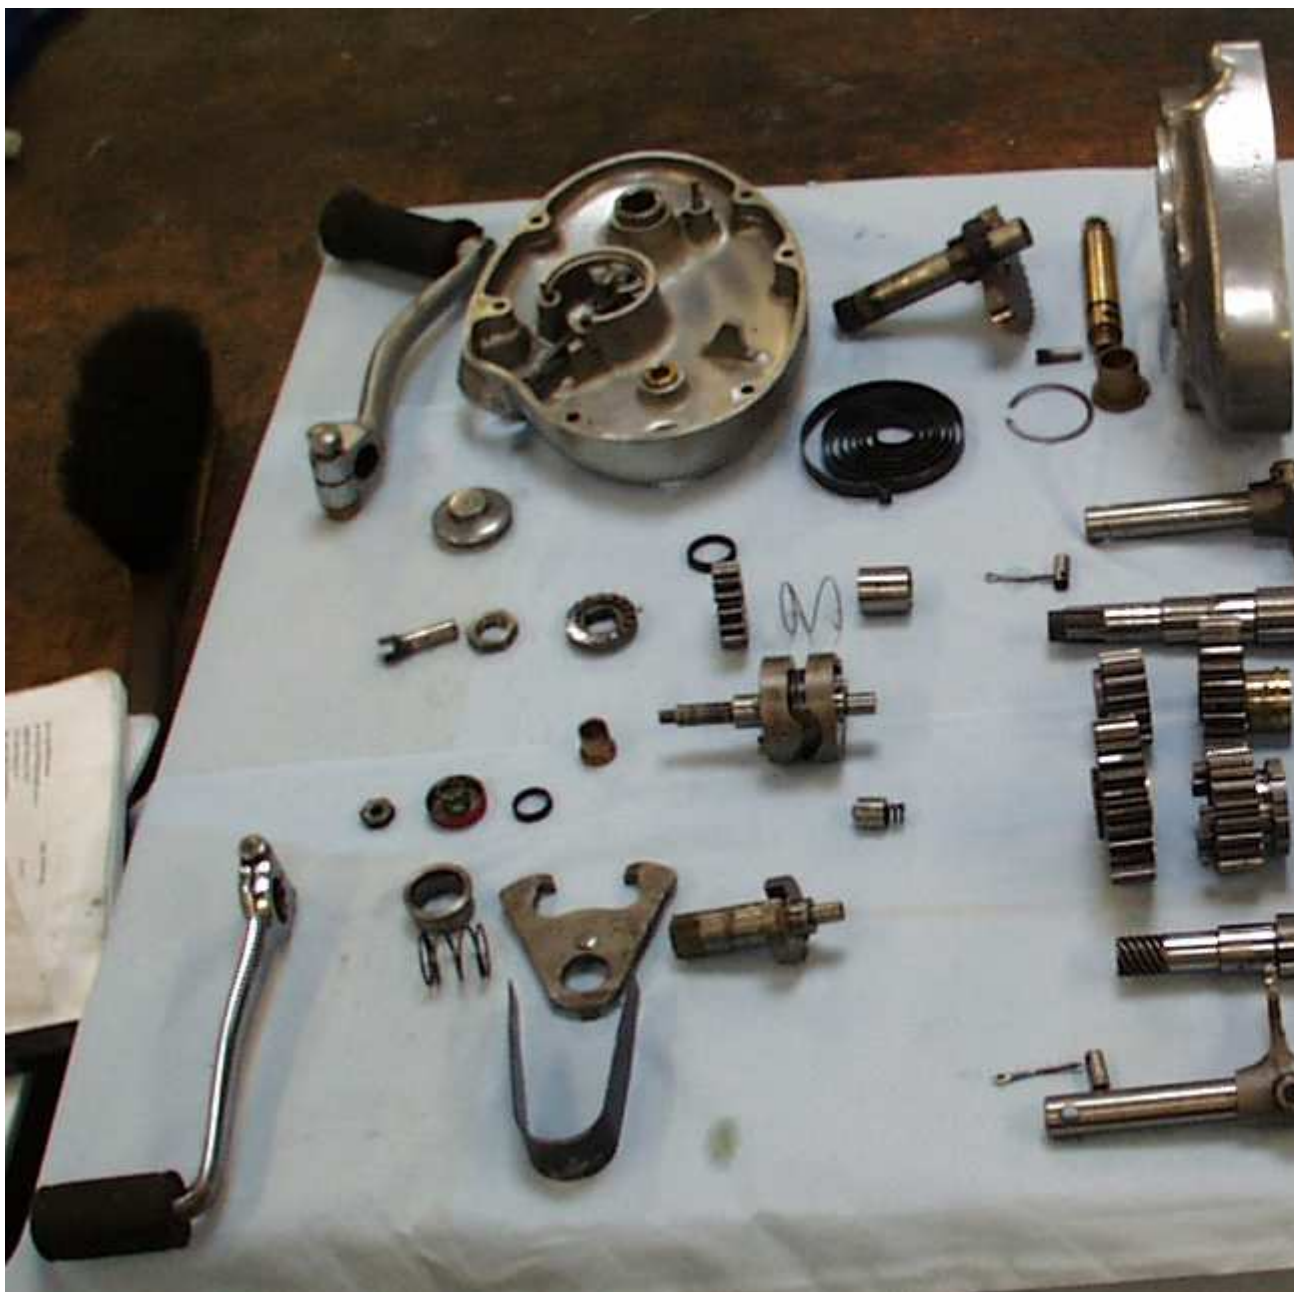
The pictures to the right right show the fully disassembled gearbox, minus one or two clips or lock washers (check the parts drawing). A copy of the parts and general service manuals can be obtained from [Roger Gwynn, Draganfly Motorcycles](#).

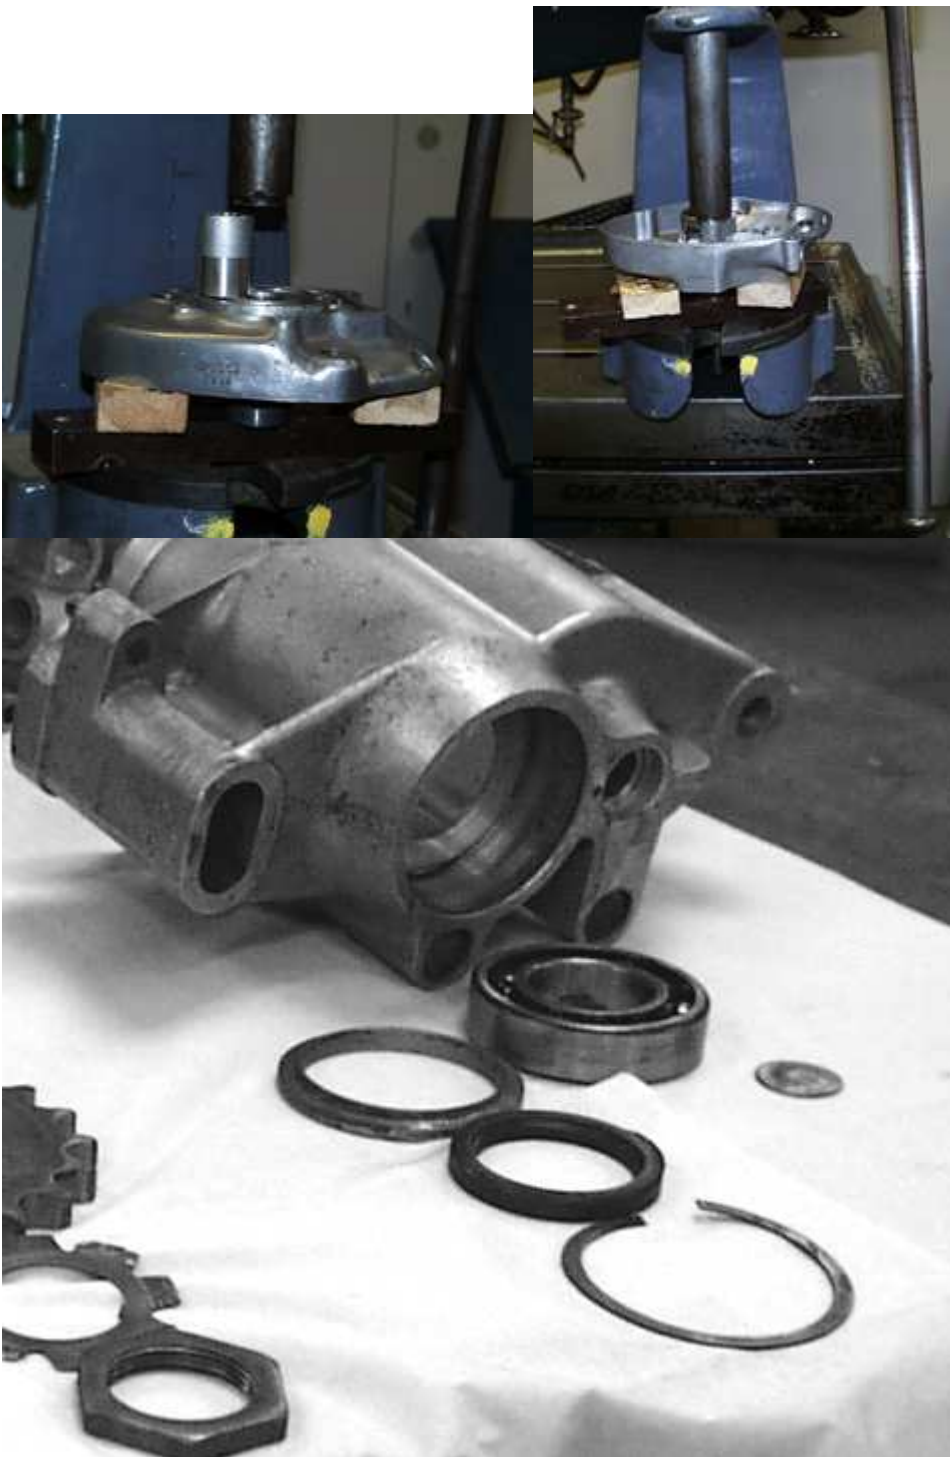
The Main bearing assembly did take some consideration in how to take out the bearing. It is not clear on the parts illustration that there is a steel ring in front of the bearing, held in place with a circlip. The oil seal sits on the outside of this subassembly and so masks the fixing.

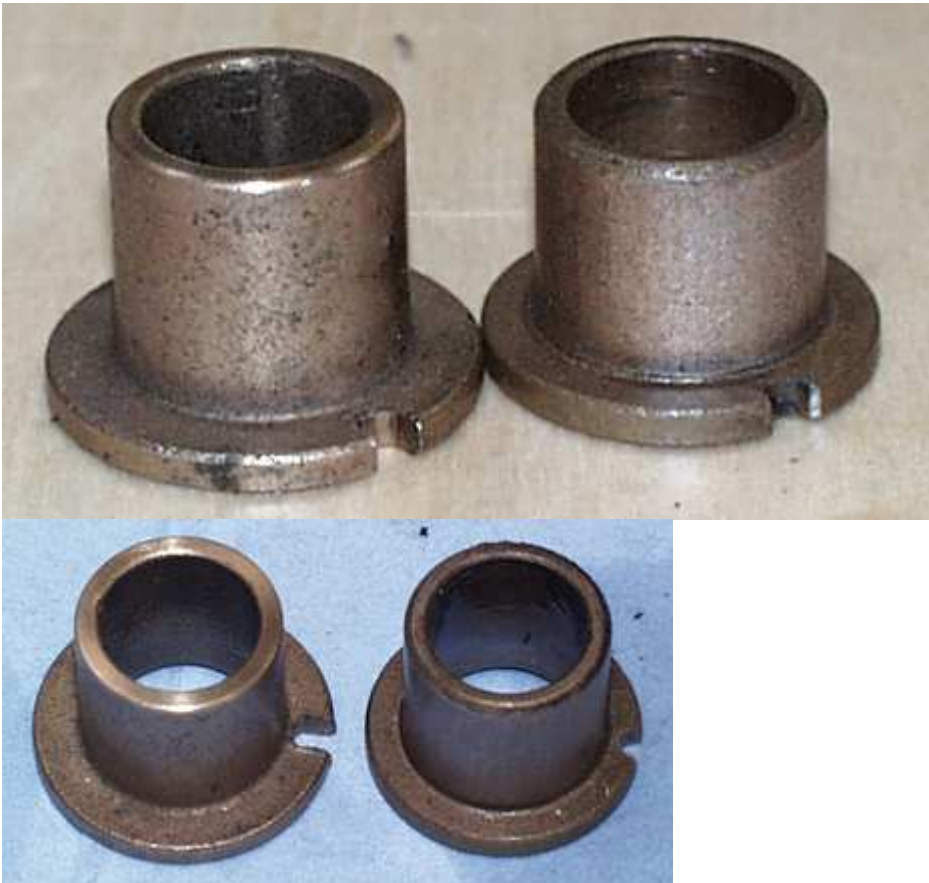
I used a fly press without heating to remove all the bearings. I made a number of drifts to fit closely to the inner and outer section of the bush/bearing being pushed out, +/- 0.2mm or 0.040" British imperial, as shown in the images left. Using the fly press did cause some concern with the gear selector kick start outer casing, as it developed a small crack radiating from the kick start shaft hole. I cannot be sure if the crack was due to the press action and uneven casing support or just wear.

I did have to use a Birmingham Drift tool (an offset chisel-like piece of metal) to remove one of the outer casing oil seals.

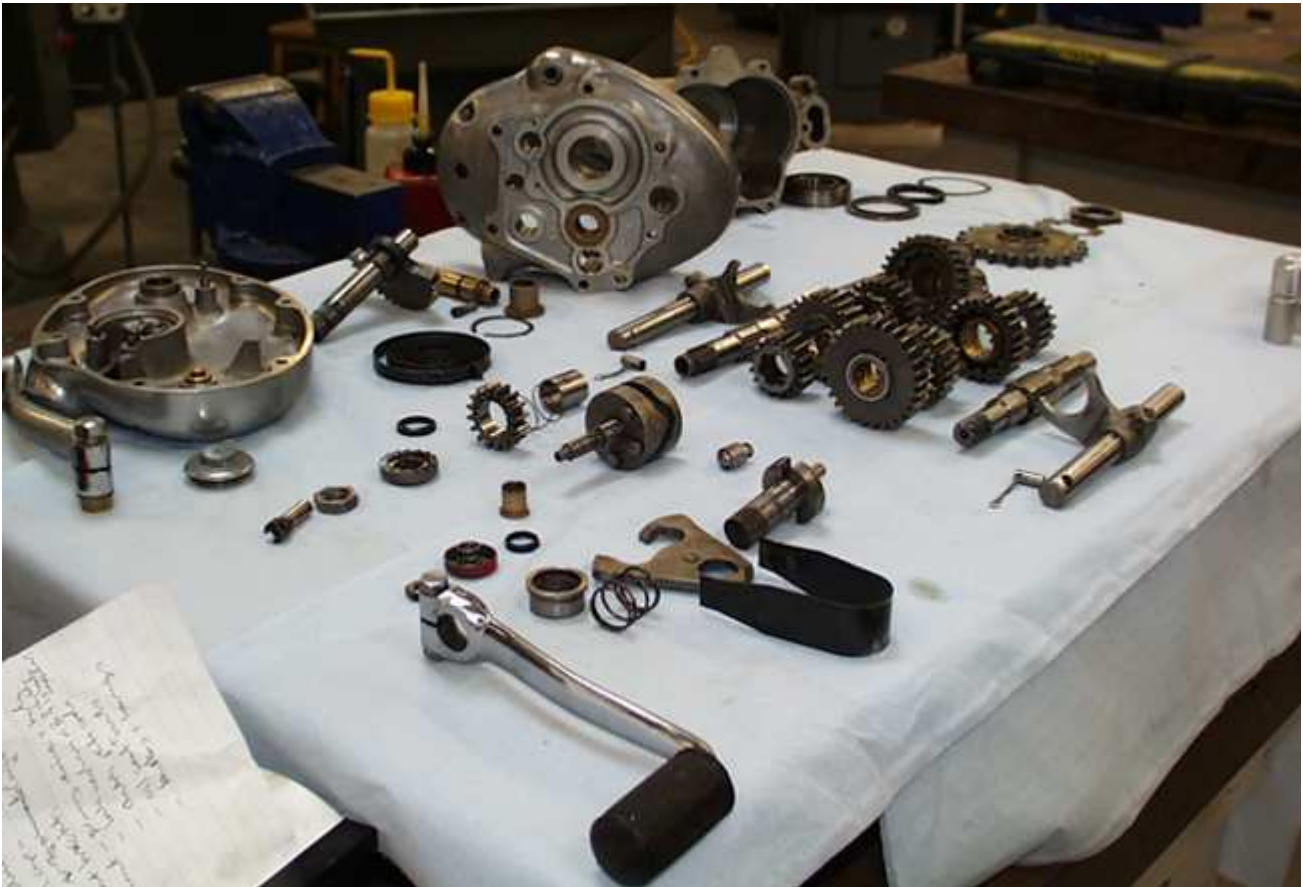
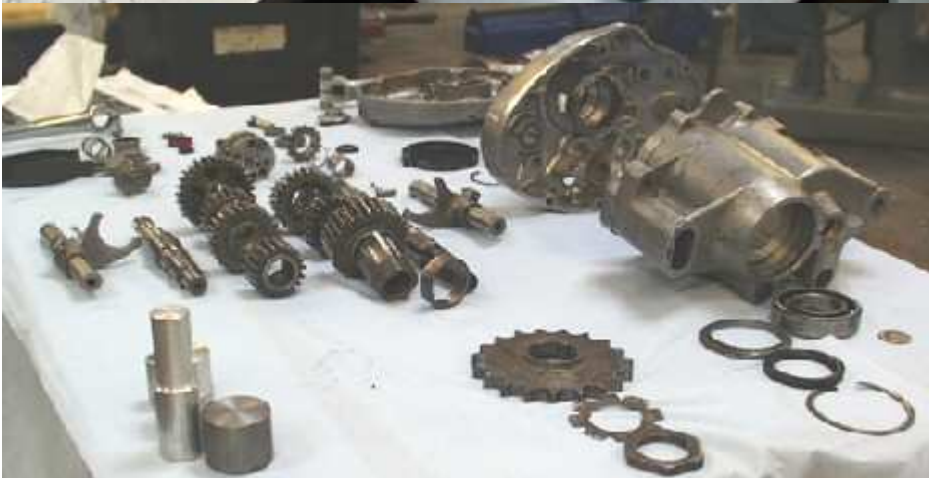
The pictures to the right are thumbnails of the full gearbox parts from a number of views, to allow you to study where everything goes in more detail.
