Fettling AJS and MATCHLESS Two-fifties

SERVICE-
SHOP
LORE
No 13

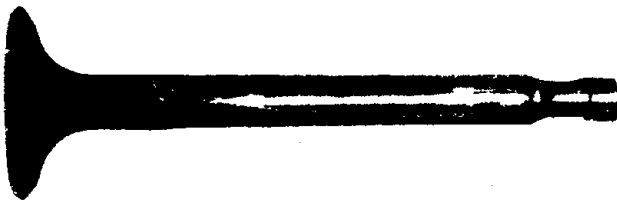
Left: The dark patches on the valve stem are the signs of burning caused by gas escaping between the stem and worn guide

SIGNS of burning on the valve stems usually are an indication that the guides are worn.

Both guides are retained by an external circlip. The drill is to heat the head gently and

tap each guide upward until the circlip can be removed from its groove.
