# AJS gearbox rebuild

Virgin restorer Neil Webster looks at the internals of his little AJ's gearbox and immediately calls in expert Bill Redford to undertake the strip and rebuild. Only the engine to do now...the bike will be on the road soon, promises Neil

## AJS 250 restoration: part nine

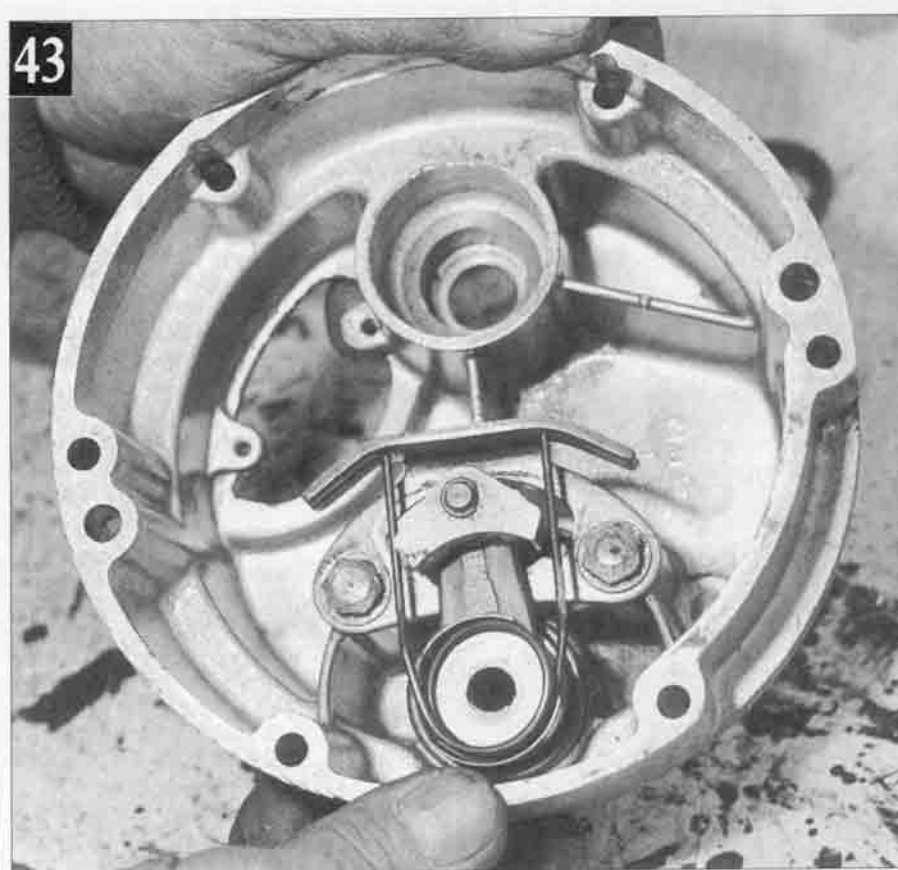
43

● As the original wasn't in bad condition Bill decided it would be alright to risk it and slotted the unit into place (pics 41, 42 and 43). With the gasket fitted and shafts oiled the outer cover then slipped into place; movement on the gearchange and kickstart mechanisms checked; and the cover screws refitted.
