IN THE WORKSHOP WITH

Your A.J.S. or Matchless

PART I—THE ENGINE

Helpful Notes for Owners of Machines in Two Popular Single- and Twin-cylinder Ranges

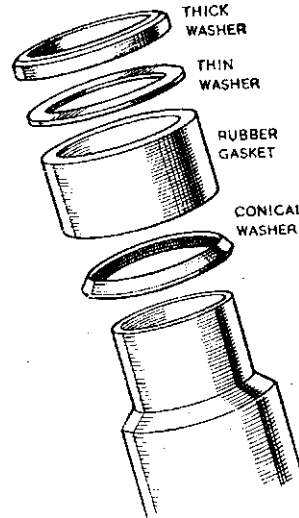
The four pushrod cover tube sealing components referred to in the text and table

On the five-hundred singles a compression plate was fitted under the cylinder barrel until 1952; when the plate was discarded the barrel length was increased accordingly. If the plate is fitted and is no longer wanted, it is essential for the ridge at the top of the cylinder barrel to be removed by scraper at the same time or ring breakage is very likely to result. It is also necessary to remove the 1/4in-thick plain washers above the rubber pushrod-sealing sleeves in the head.

There has, in fact, been considerable variation through the years at the upper end of the pushrod cover tubes. Four possible items can be located on each tube: from the top they are a thick (1/2in) washer, a thin (1/4in) washer, a rubber sleeve and a conical washer. These items are designated respectively A, B, C and D in the table herewith, which gives the

Date	350 c.c.	500 c.c.
Pre-1950	B, C	A, B, C
1950 and 1951	B, C, D	A, B, C, D
1952 onward	B, C, D	B, C, D

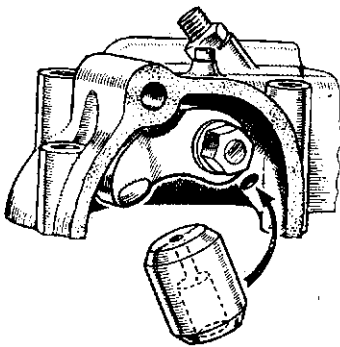
Valve-gear lubrication of pre-1954 singles can be modernized by fitting an additional metering plug in the rocker box

Valve-gear lubrication on the singles is from the pressure side of the pump and the system was modified in 1954 to increase the supply to the inlet spring and valve end, with the object of reducing wear on the spring where it contacts the collar. Hairpin-spring engines built prior to 1954 can be brought up to date in that respect with little difficulty. It is necessary to enlarge to 7/8in the oil hole drilled in the exhaust rocker-spindle boss and to insert a metering plug (Part No. 018890). The plug should be inserted small hole first and tapped home with a

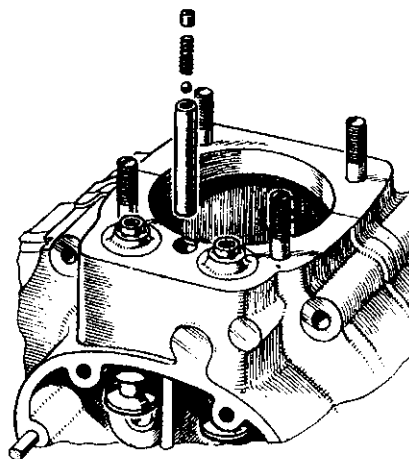
Single-cylinder A.J.S. and Matchless engines made before 1956 have a ball valve controlling cylinder-wall oiling

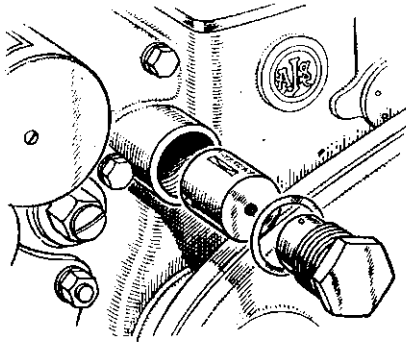
Above: The crankcase-breather valve of the later twins is in the end of the mainshaft

Oil seepage from the crankcase into the primary chaincase on twins from 1952 onward, is usually the result of a broken or buckled diaphragm in the crankcase pressure-release valve in the end of the crankshaft. The body of the release valve retains the shock-absorber spring. The valve should be removed complete and dismantled by lightly gripping the body in a vice and applying a spanner to the spring-retaining sleeve nut. If the sleeve nut is undone with the body *in situ* there is a risk that the body, which is rather thin, may be collapsed at the thread. The diaphragm must be flat, undamaged and free to rotate in the body. Should oil seepage to the chaincase occur on earlier twins, the first thing to verify is that the rubber tube from the release valve is not kinked or otherwise obstructed.

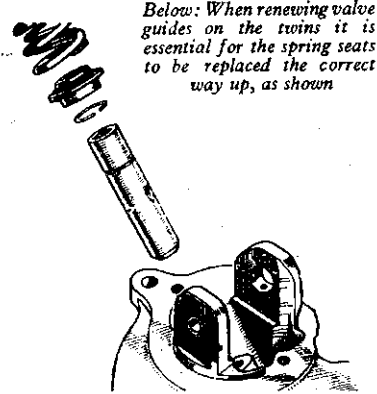
Below: When renewing valve guides on the twins it is essential for the spring seats to be replaced the correct way up, as shown

The remarks already made regarding valve guides with circlips and about avoidance of excessive valve grinding apply equally to the twin-cylinder engines. After attention to the valves or guides the valve-spring seats must be replaced the right way up, i.e., with the stepped face of the flange upward; incorrect installation will result in the inner springs becoming coil-bound at full lift.

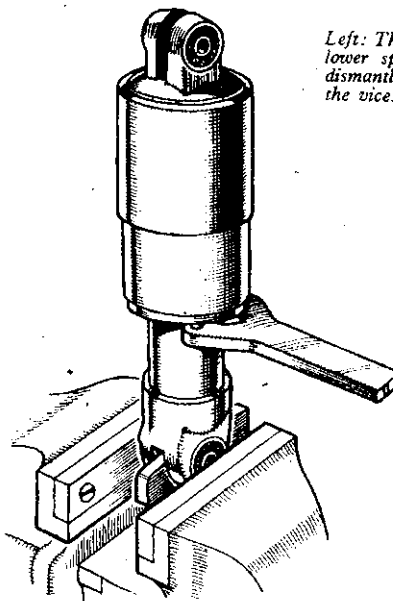
Left: The earlier "jampot" shock absorbers have a screw-on lower spring abutment and a peg spanner is needed for dismantling. Note the distance piece between the ears in the vice. Above is shown the method of holding the inner tube while the top anchorage is unscrewed

On the pre-1955 shock absorbers the spring-abutment collar can be unscrewed with a peg spanner. To enable that to be done, either the outer tube can be held in a split clamp in the vice or the bottom anchorage can be gripped after interposing a close-fitting distance piece between the ears to avoid distorting them. When the collar has been unscrewed the rest of the dismantling is as already detailed.
