# Fettling AJS and MATCHLESS Two-fifties

SERVICE-  
SHOP  
LORE  
No 13

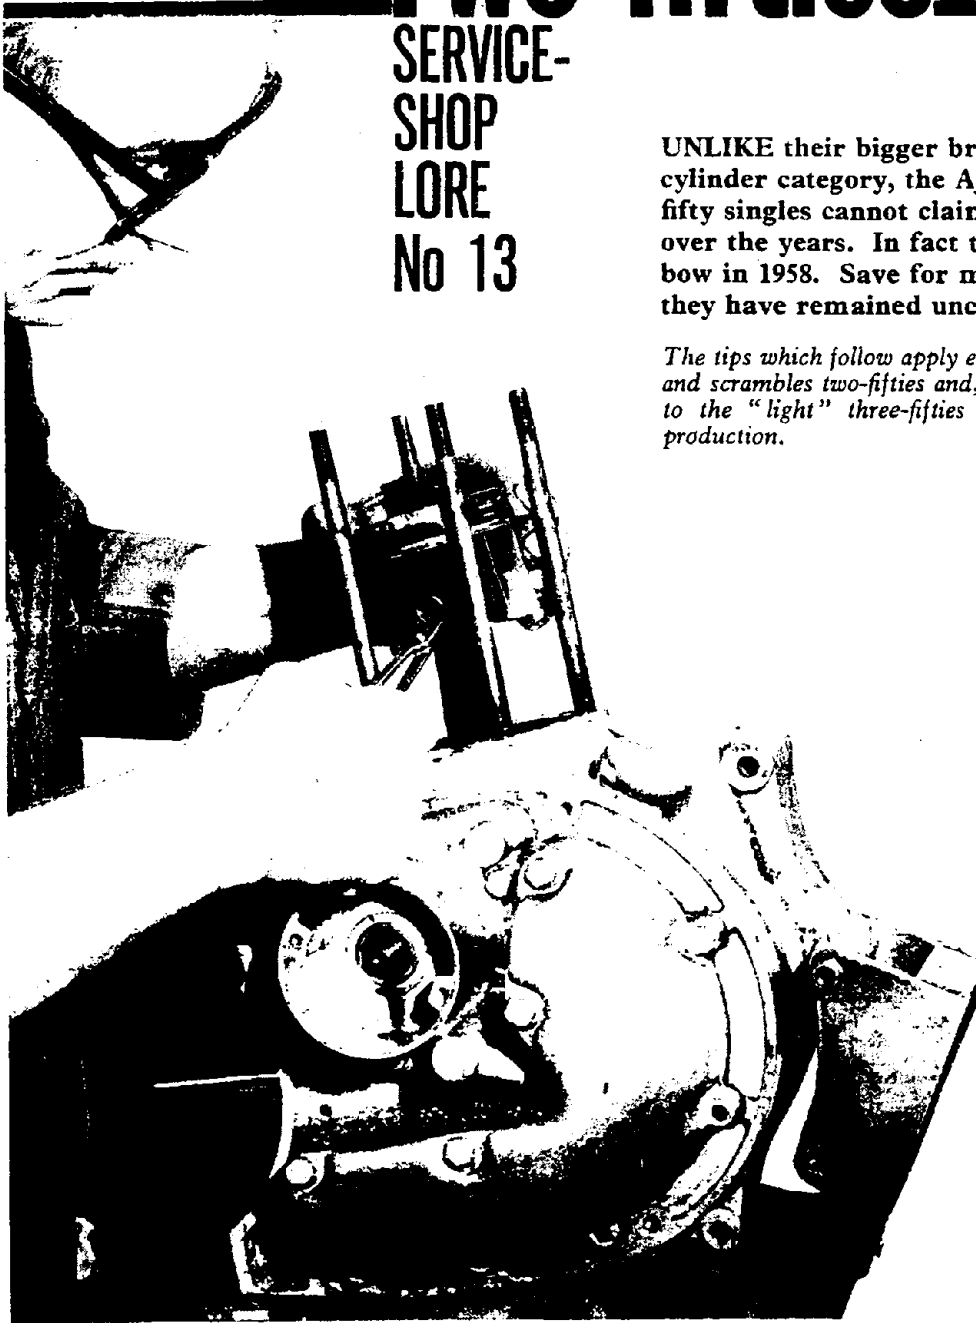
Left: Indicated is the rocker box retaining bolt which sometimes gets forgotten. The inlet valve is shown open. Both valves should be closed before attempting to remove the rocker box. Right: Before setting the timing, the bob-weights should be held in the advanced position

WHEN removing the rocker box set the piston at about top dead centre with both valves closed; and remember that one retaining bolt cannot be reached until the inspection cover has been taken off.

**A**LWAYS set the ignition timing with the automatic device in the full-advance position.

The bob-weights (and hence the cam) can be levered to full advance with a screwdriver passed through the hole in the contact-breaker back plate. But it is difficult to hold the weights in that position while setting the timing.
