Norton gearbox

NORTON AMC gearbox overhaul with
Norton specialist Mick Hemmings.

This stripdown and rebuild feature was done on a gearbox from a 1965 750cc Norton Atlas and can be used as a guide for four-speed Norton gearboxes from 1956 onwards. Relevant models include the 600cc Model 19S, 500cc ES2, and 350cc Model 50 which are all single cylinder models; the 850/750cc Commando, Atlas, Ranger, N15, G15 Matchless (which was Norton powered), the 650cc Mercury, Manxman, 650SS, the 600cc Model 77, Model 99, the 500cc Model 88 and Model 7, which are all twin cylinder models.

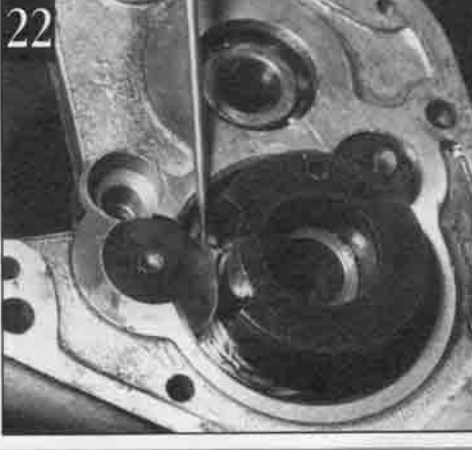
● Ease off the kickstart shaft while supporting the spring loaded pawl (pic 19). Take out the components (pic 20) being careful not to lose any of them and inspect the pawl for wear. In this case the pawl

was still serviceable but the spring had become shortened. Pic 21 shows it against a new one which was fitted during rebuild. Free length of a new spring is 1.3-1.4 inch. At the same time it was decided to fit a new pawl pin.

- Assemble kickstart ratchet assembly with new spring and pawl pin. These components must be in good condition or the pawl and gear can be damaged, and the pawl alone costs £4.

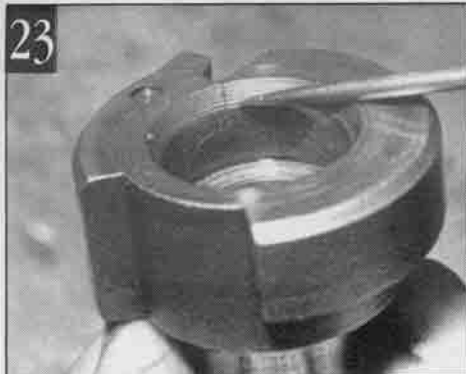
● Check the kickstart shaft for cracks as shown in pic 23. A crack such as this means a new shaft is necessary. Here the shaft is relatively weak because of lack of metal.

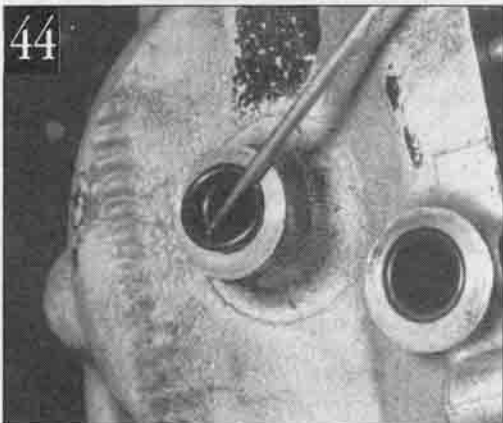
- Check the gearbox shell for signs of cracking as pointed to in pic 38. This one was fine. But it's not uncommon to find cracking caused by the layshaft bearing exerting pressure on the shell. If this is the

case the shell should be replaced.

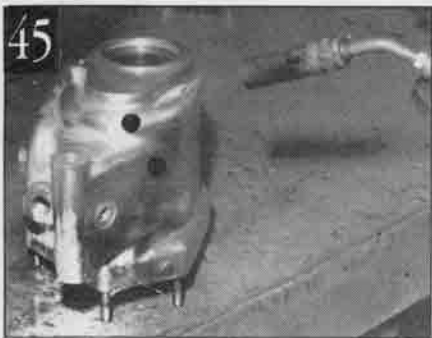
● The home DIY mechanic can either put the shell in the oven for an hour or so to heat it, or use a blow torch (pic 45) to

warm the cases so that the main and layshaft bearings can be knocked out. Mick always replaces bearings as a matter of course. After heating, the bearings usually fall out. If not then a light tap using an appropriately sized socket, for example, as a drift should free them. Or simply whack the casing against a block of wood to shock the bearings free. If heating with a blow torch play the flame over the whole of the casing to uniformly heat it. Concentrating the flame around the bearing only may result in distortion of the shell. A simple way to tell when the shell is hot enough to free the bearings is to spit on it. Ungentlemanly? In that case sprinkle some water on it. If it evaporates instantly then the shell is warm enough.

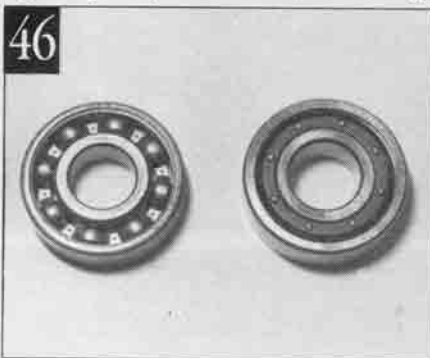
The layshaft bearing is known to be a weak point in the AMC gearbox, and so a high quality Tufnol bearing (shown on the right in pic 46) was selected, even though

at £18.50 including VAT it is much dearer than the £2.92 standard type, or £12 roller bearing.

The Tufnol bearing features a flexible rather than steel cage. This allows flexing of the layshaft with much reduced possibility of the cage breaking up, the main cause of layshaft bearing failure.

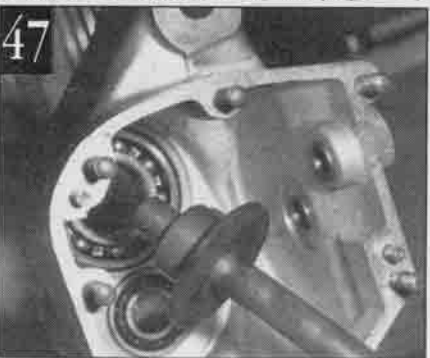
The new bearings should be ready for insertion while the shell is still warm. Mick has made up his own tool for pressing the bearings home squarely (pic 47).

The DIY mechanic could follow this example or use a socket with care. Use the back face, so to speak, of the socket to press against the bearing, and never try to press a bearing home by putting pressure on its inner race only. Press against the bearing as a whole or against the outer race.

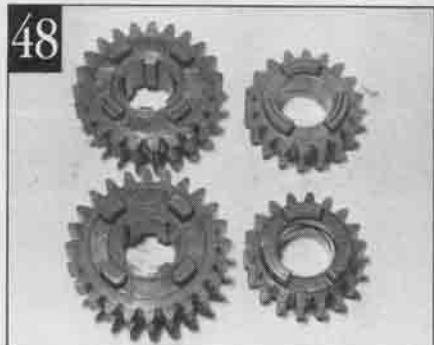
● Further uprating on pre-Commando gearboxes can be carried out by fitting later Commando second gears. These must be fitted as a pair. Later (Mk 3) Commando gears are identified by the grooves in their dogs (top pair in pic 48).

They are better for tuned engines because the teeth mesh over a wider area to spread the load. The Commando gears are bigger in overall diameter, hence the need to change them in pairs. They mesh more deeply with each other, thus there is no problem with shaft-to-shaft dimensions.

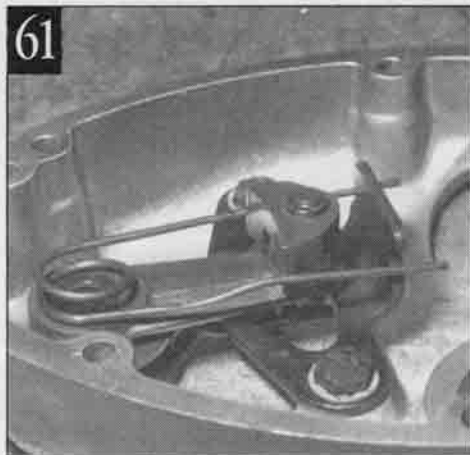
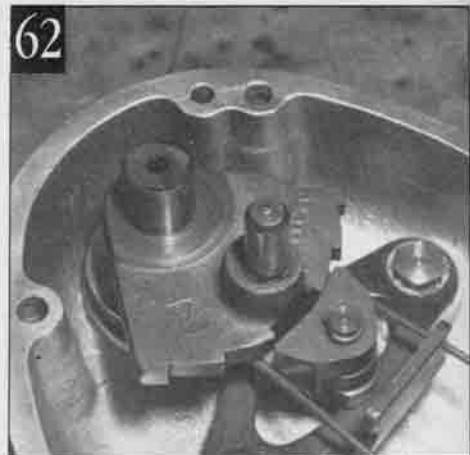
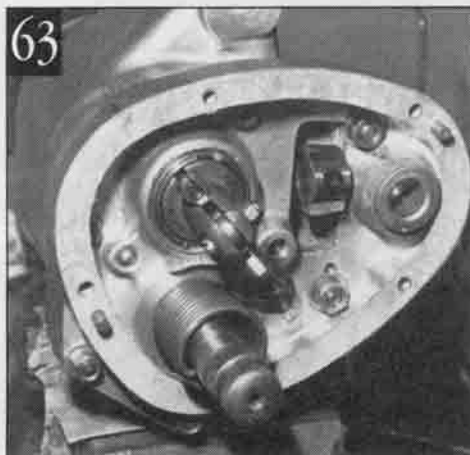
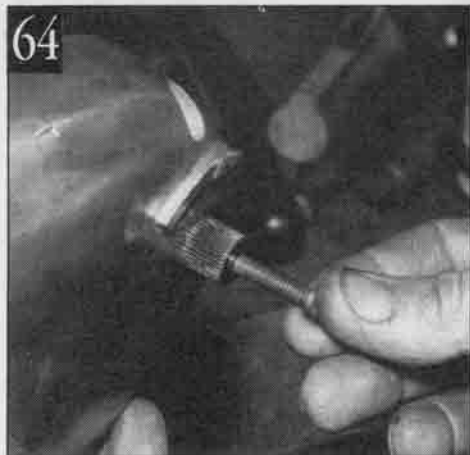
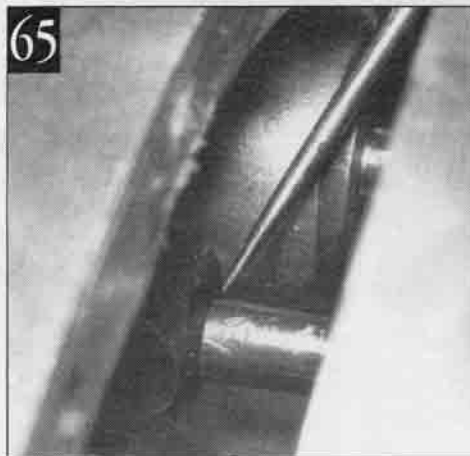
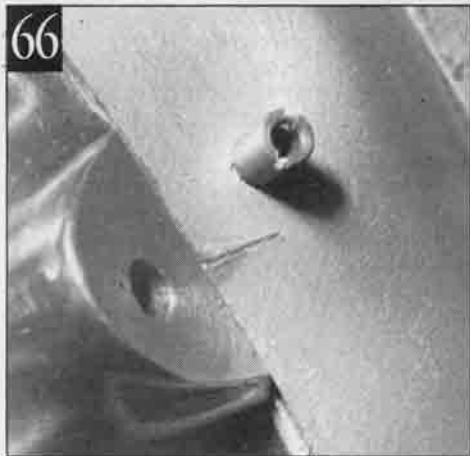
- Fit gearchange hairpin spring with straight leg uppermost (pic 61). If you fit this the wrong way round you won't be able to select gears. Insert gearchange ratchet after oiling shaft making sure half moon quadrant is pointing towards the teeth (pic 62).

- Before the outer cover can be fitted lever the quadrant to select second gear and make sure the hole in the quadrant roller points outwards (pic 63). Fit new gasket greased both sides. Insert a suitable screw to the centre of the gearchange spindle (pic 64). This allows you to move the gearchange mechanism housed within the outer cover.

- Now you can attempt to fit the outer cover. The art is to locate the pin on the ratchet assembly into the quadrant roller (pic 65). This looks straightforward in the picture, but it can be a real fiddle. It is also important to make sure the clutch actuating lever doesn't get in the way. To prevent this use the clutch pushrod to push back the clutch mechanism so that the actuating lever is lifted. You may also find it necessary to slip the gear lever on to make it easier to wriggle the outer cover home.

- To improve gearbox breathing on pre-Mk3 Commando gearboxes MH recommends drilling the inner cover to accept a main jet or the Mk 3 breather (pic 66). Obviously this should be done during the stripdown stage if desired.
